# COMPREHENSIVE CONDITION ASSESSMENT

## WOOD CREEK LODGE ROOF

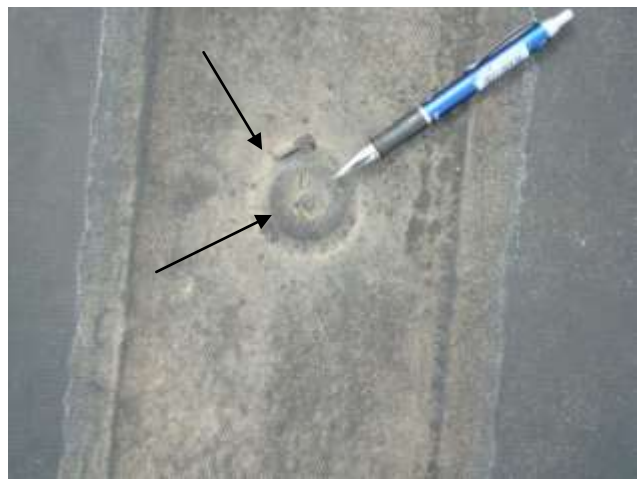
Round spots are the EPDM over fasteners that attach underlayment board to the roof deck. Cracking and small cuts are depicted in this photo at the tip of the arrows. They are about a 1/4" in length.

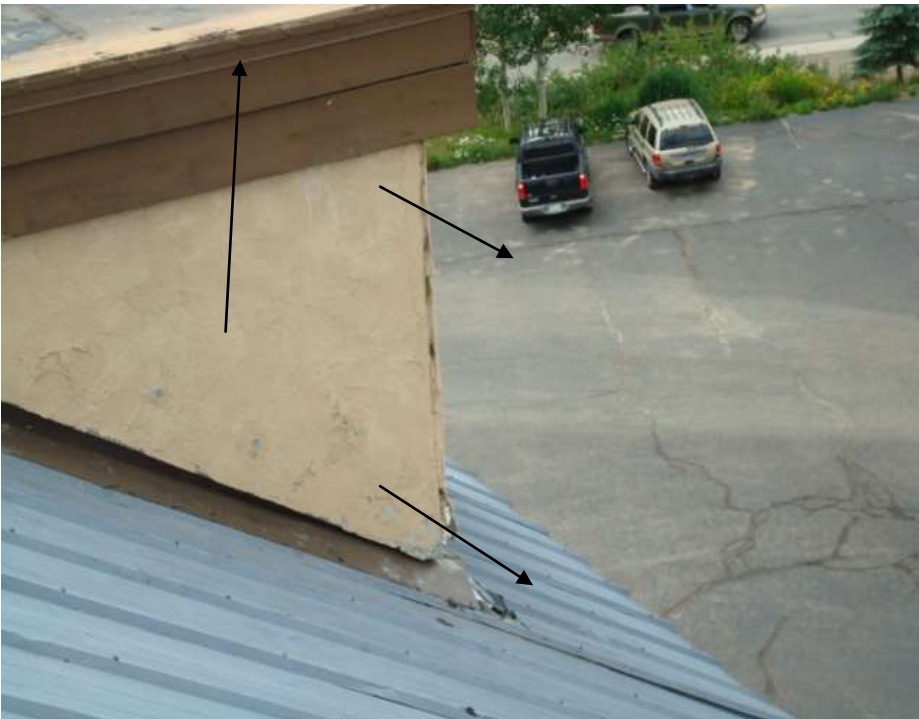
NW corner of upper roof deck. Photo attempts to depict a condition where the stucco at the corner is deteriorated to the point that water could penetrate (lower arrows). Attempts have been made to seal the stucco on these corners. Likewise, the seal between the edge metal and EPDM is starting to deteriorate (top arrow). Due to steepness of metal roof deck, unable to closely inspect the vertical corner or flashing. The metal roof deck appeared to be in fair condition.

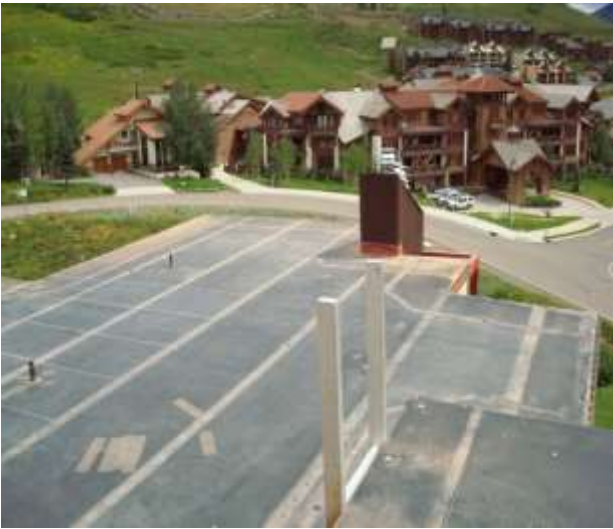
Overall photo of Roof Deck 2 from Roof Deck 1. Patching from previous repairs are visible.

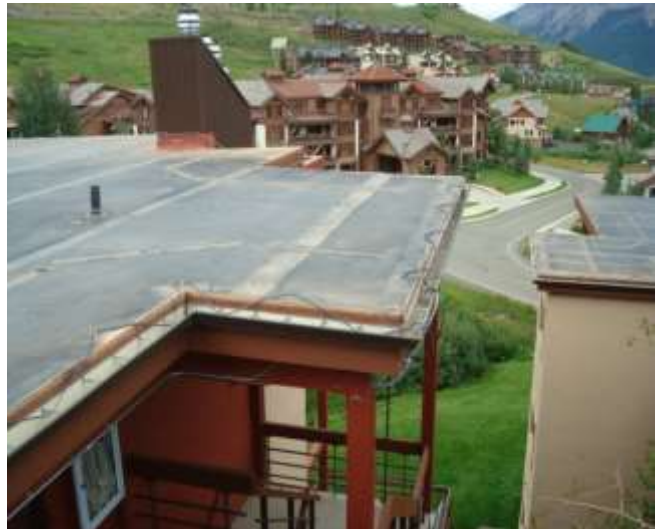
Roof Deck 2. Photo depicts snowmelt cable at roof edges and in rain gutters. This detail will be carried over into the replacement roofing.

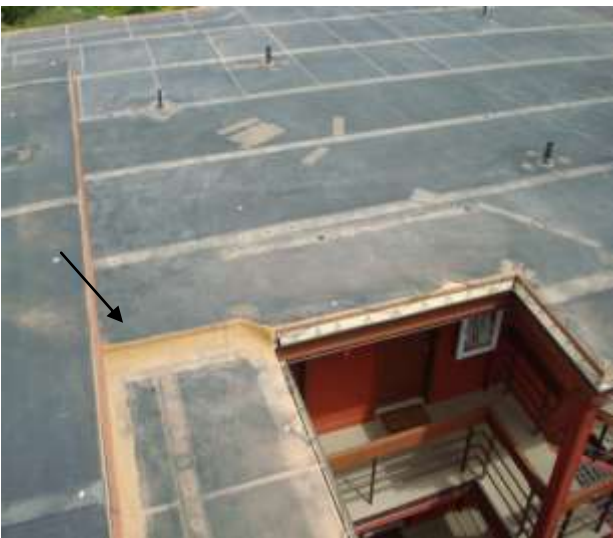
This photo shows Roof Deck 2 from Roof Deck 1. There is a 10" step down from Roof Deck 2 to Roof Deck 3.

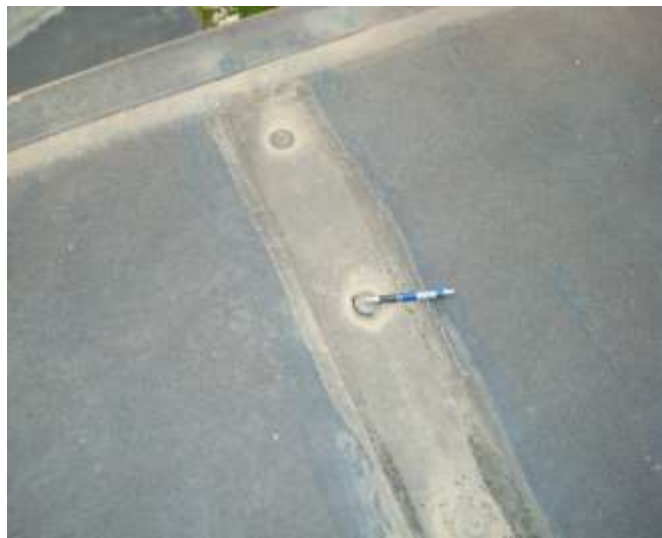
Same type of crack/cut at the covered fastener as noted on Roof Deck 1. All roof sections had this condition at various locations.

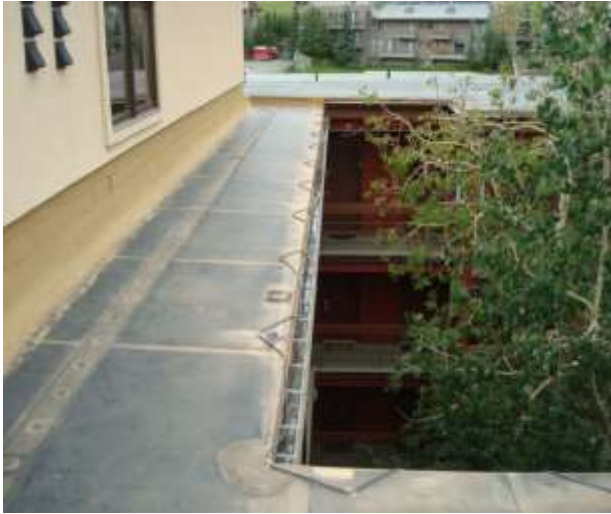
Photo depicts snowmelt cable at eaves and rain gutters. Shown in PHOTO 11 below is “checking” in the EPDM surface. This was noted in this area.

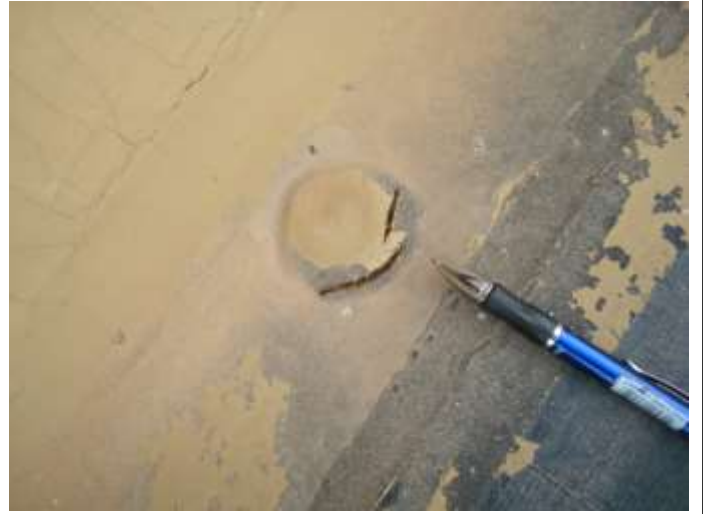
A little more pronounced cut/crack. This IS an area where a cut was made into the roof deck to determine if water intrusion has caused problems.

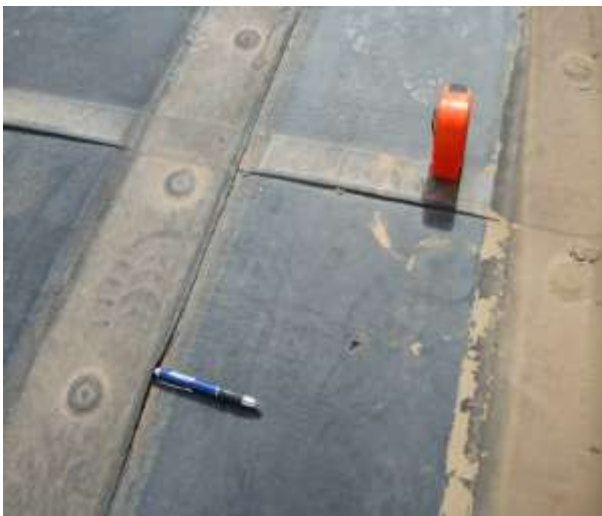
Photo shows loose seams between EPDM. To avoid further damage these seams were not probed. They should not be loose.

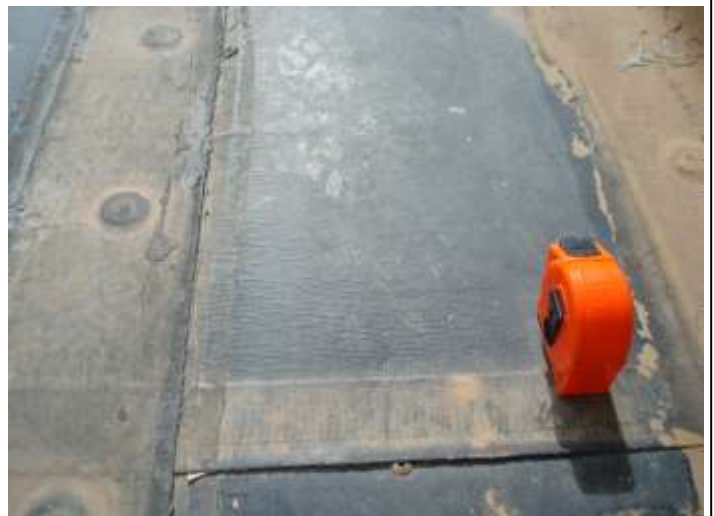
Photo depicts loose seam and checking. Checking is hard to see in the photo but is a sign of aging EPDM subjected to conditions prevalent in Mt Crested Butte. This area will be investigated to the wood deck.

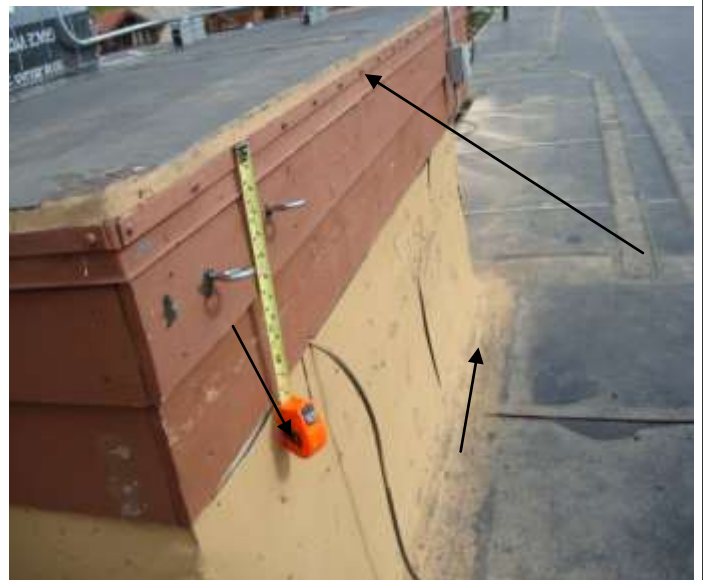
Photo shows loose flashing below wood fascia. Also, metal edging with exposed fasteners. Single ply roofing manufactures today still use the edge metal to hold the single ply along edges but the edge metal is sealed with an adhesive applied membrane strip. Fasteners and metal (termination bars) are not exposed in more modern installations.

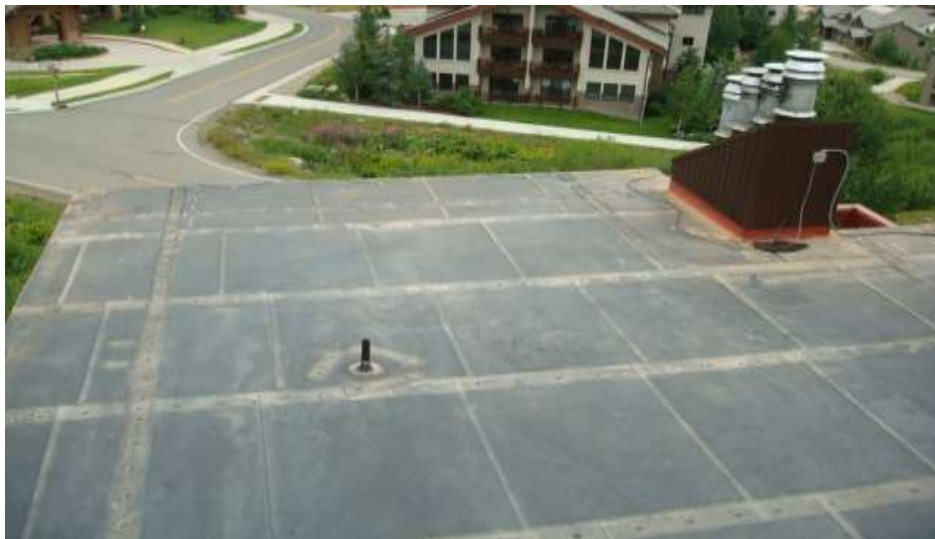
Roof Deck 4 exhibited similar small cracks as other roof decks.

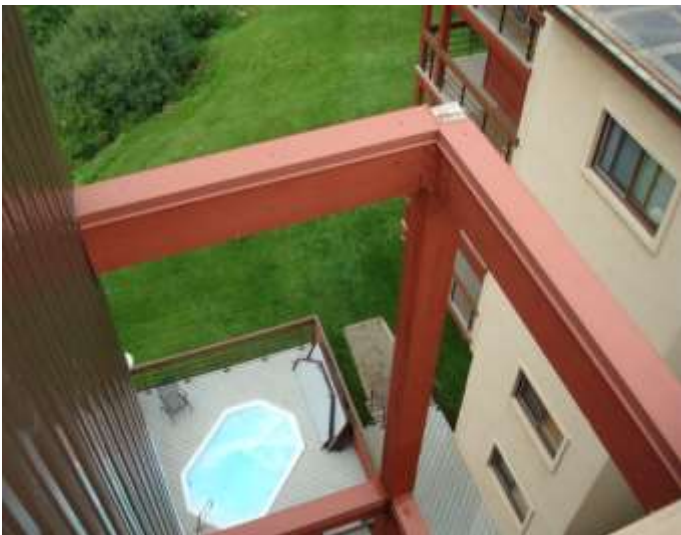
Top of wood column exposed to elements.

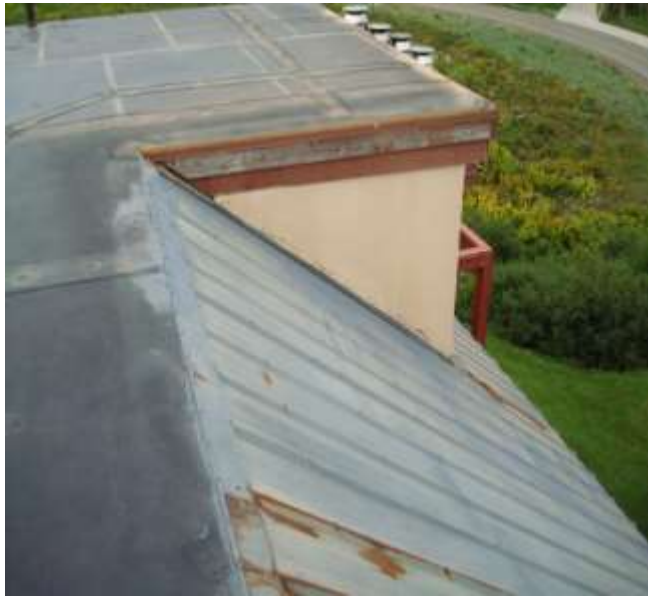
Weathered wood fascia and trim. Re-staining should be performed soon. Also, photo depicts aged metal deck.

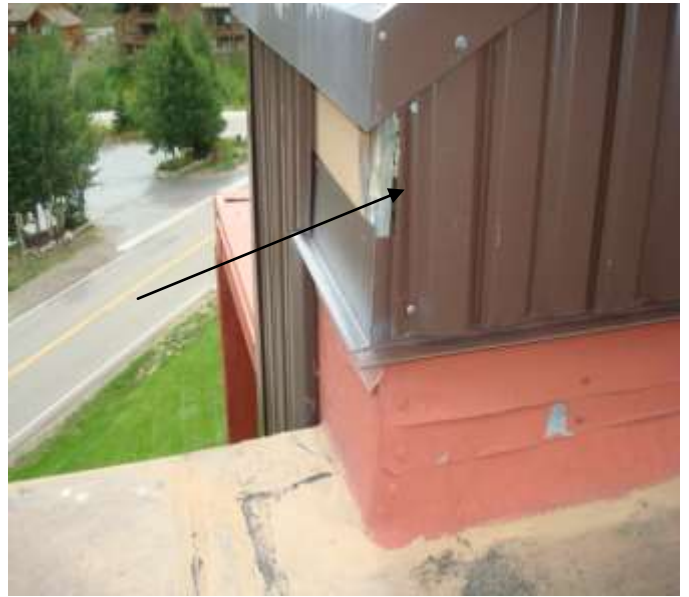
Corner flashing damage.

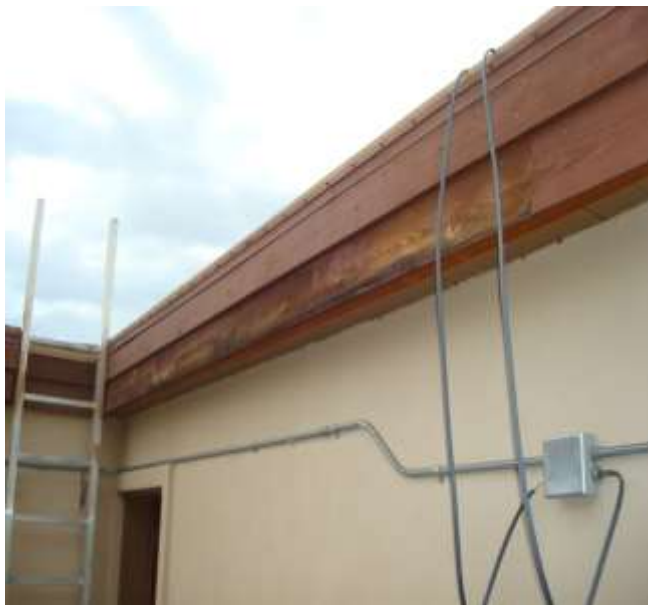
Weathered fascia and trim. Re-staining should happen soon.

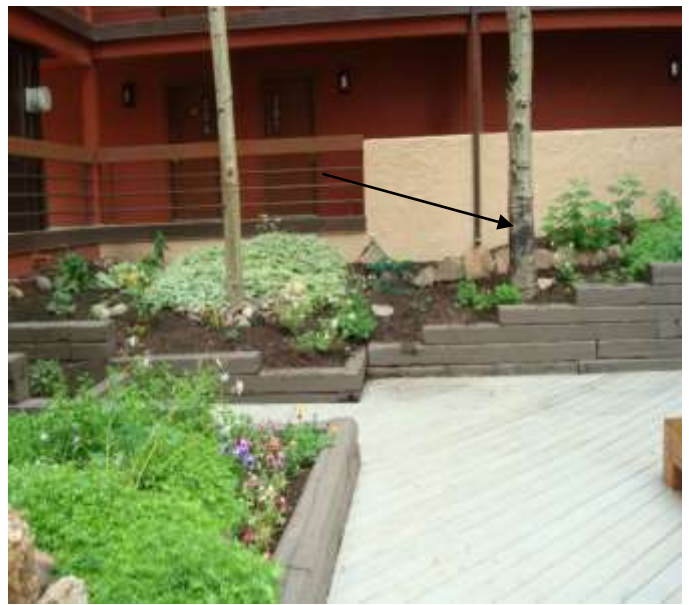
Roof downspout could bring significant water to this area. Is this problematic? Other downspouts could potentially drain water to areas where not wanted. This will be studied further as part of the building and grounds assessment.
