# **WOOD CREEK LODGE**

CRESTED BUTTE COLORADO

## **CAPITAL IMPROVEMENT PLAN STRATEGY**

**MAY 6, 2015**

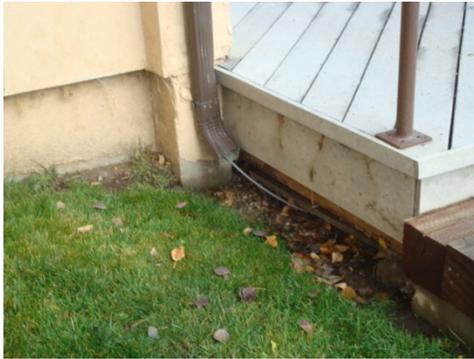
Photo 1

3. Grading and drainage: In general the grading and drainage around the structure and parking area is in good condition with a couple exceptions. One exception is the drainage that enters the rutted area by the trash dumpsters. Another area has to do with the roof drains. Although we could not discern that the roof drains dumping of water into the court yard area, or elsewhere is problematic, it is a situation worth remedying at some point. Several roof drains could be routed away from the building to enhance overall drainage. One on the SE corner near the timber retaining wall is one that could be piped toward Wood Creek. Another is as shown in the photo 1 below. It is not a good practice to direct water to areas around structure or decking.

framing. We do recommend that the drainage in this area be corrected at some point in the future. We do not feel that this work is a high priority at this time however, we have placed a line item in the CIP strategy for this work. The time to do this work would be with court yard decking replacement and for some of the other roof drains when the retaining walls are rebuilt.

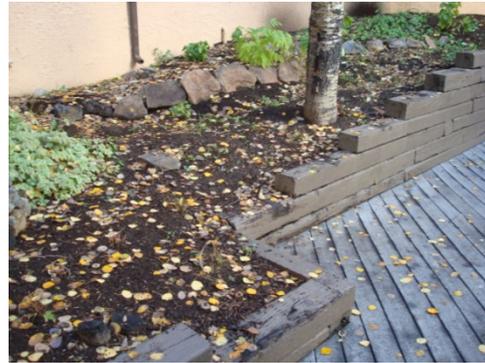
Photo 2

The court yard area roof drain would be a bit of a challenge to pipe without removing a significant amount of the decking (photo 2). The decking in photo 2 has dark areas from moisture. This moisture was mostly from recent rains (at the time of the photo). However, it is our opinion that water that gets below this deck will keep the sub structure and sub grade wet or moist. Over time this will detract from the life of the synthetic decking (it appears to be a Trex product) and sub

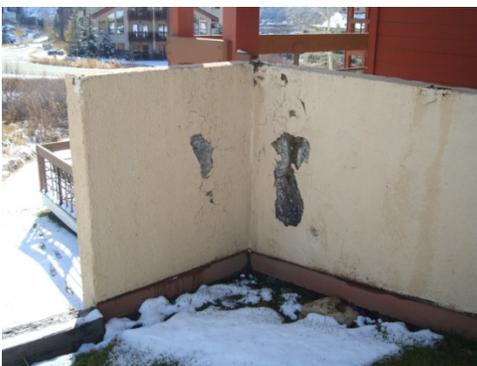
Photo 3 shows a concrete retaining wall covered with stucco. This is not an unusual application. However, when this wall is repaired the top of the wall should be capped with a metal or other material that will shed water better than the stucco that is now on the horizontal top of wall surface.

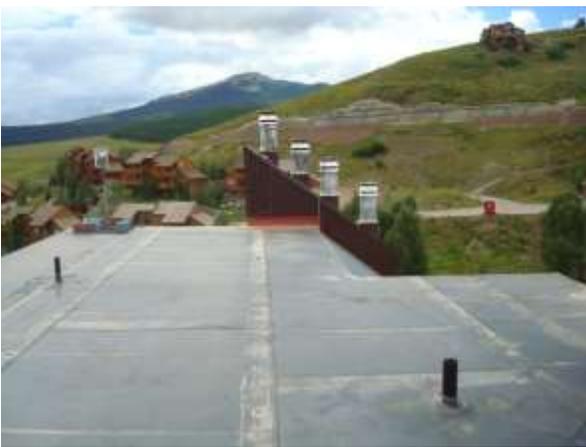
PHOTO 1

Roof Deck 1 overall photo. Photo depicts seams in the EPDM single ply roofing material, two of the three plumbing vents and the wireless LAN access point in the upper left corner.

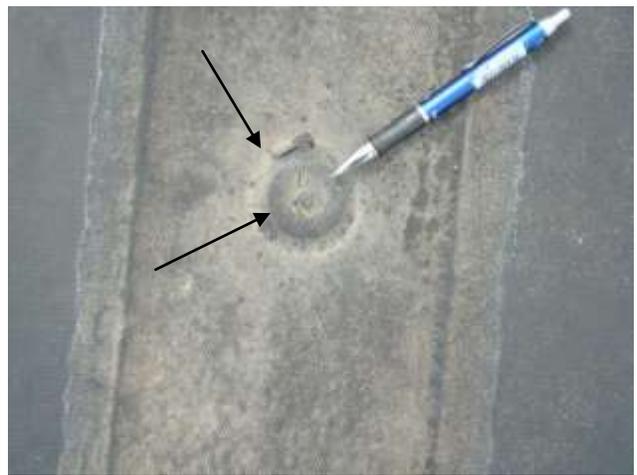
PHOTO 2

Round spots are the EPDM over fasteners that attach underlayment board to the roof deck. Cracking and small cuts are depicted in this photo at the tip of the arrows. They are about a 1/4" in length.

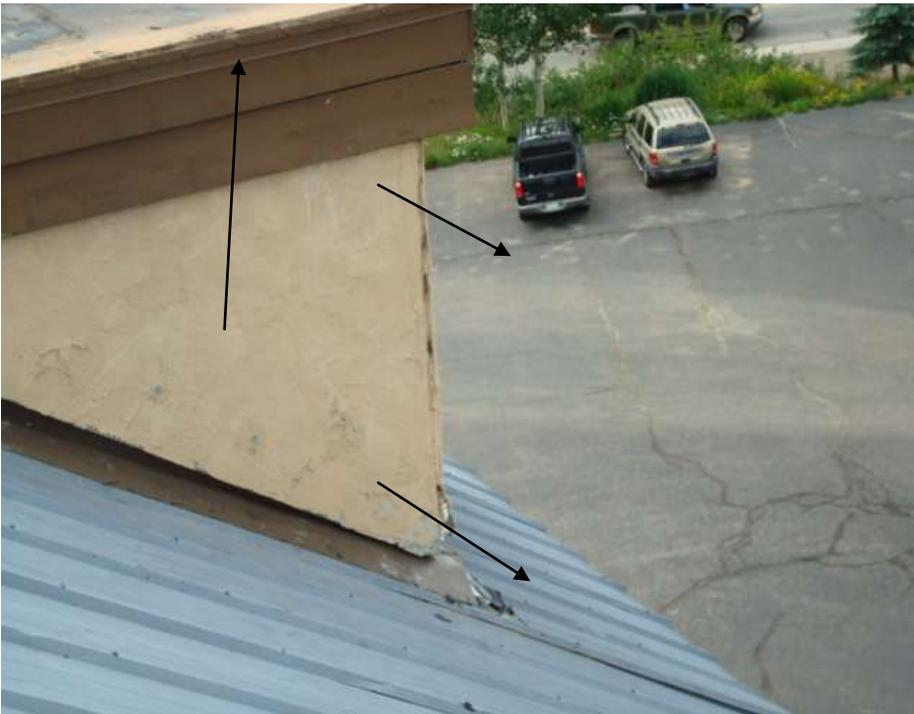
PHOTO 3

NW corner of upper roof deck. Photo attempts to depict a condition where the stucco at the corner is deteriorated to the point that water could penetrate (lower arrows). Attempts have been made to seal the stucco on these corners. Likewise, the seal between the edge metal and EPDM is starting to deteriorate (top arrow). Due to steepness of metal roof deck, unable to closely inspect the vertical corner or flashing. The metal roof deck appeared to be in fair condition.

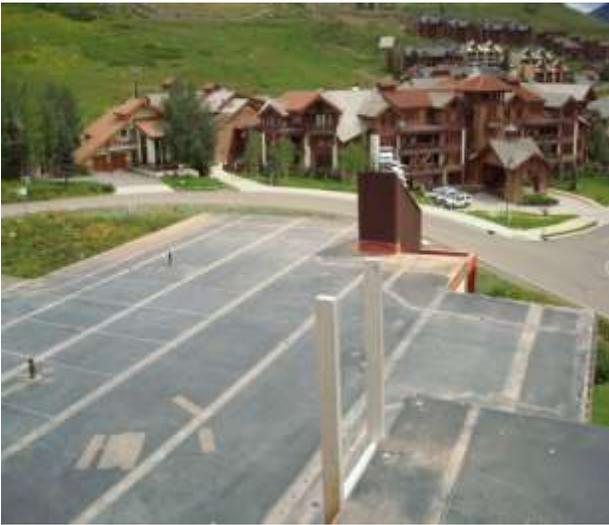
PHOTO 4

Overall photo of Roof Deck 2 from Roof Deck 1. Patching from previous repairs are visible.

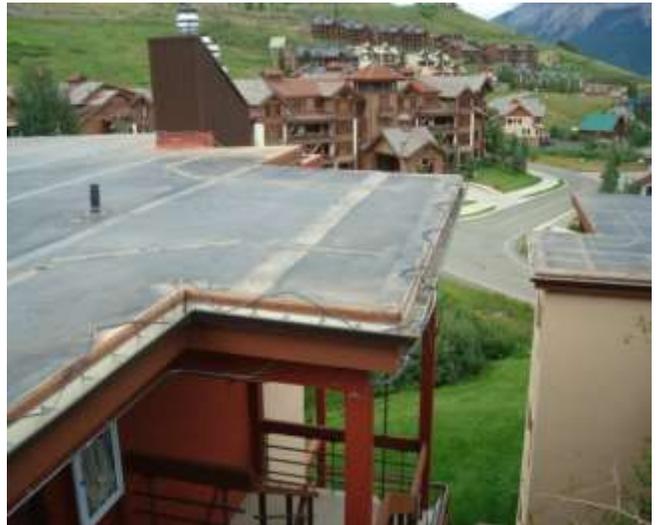
PHOTO 5

Roof Deck 2. Photo depicts snowmelt cable at roof edges and in rain gutters. This detail will be carried over into the replacement roofing.

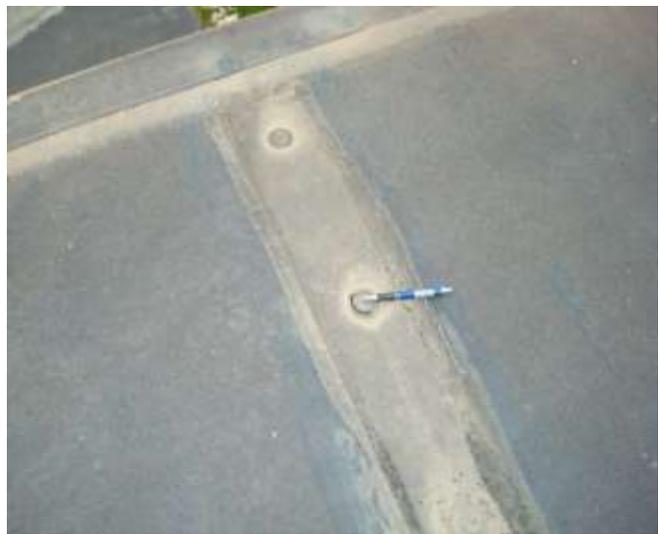
Same type of crack/cut at the covered fastener as noted on Roof Deck 1. All roof sections had this condition at various locations.

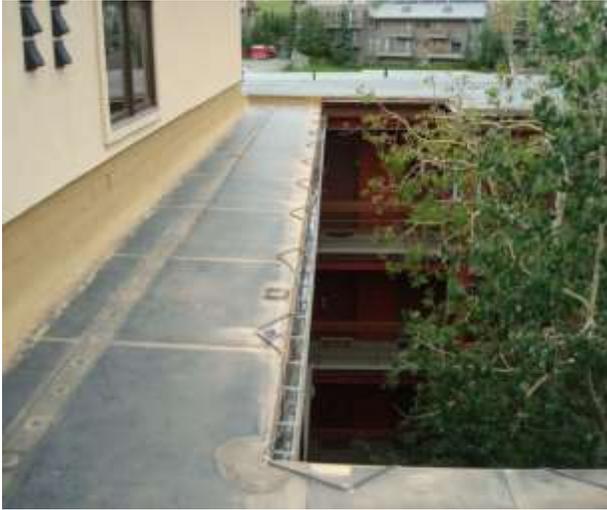
PHOTO 8

Photo depicts snowmelt cable at eaves and rain gutters. Shown in PHOTO 11 below is “checking” in the EPDM surface. This was noted in this area.

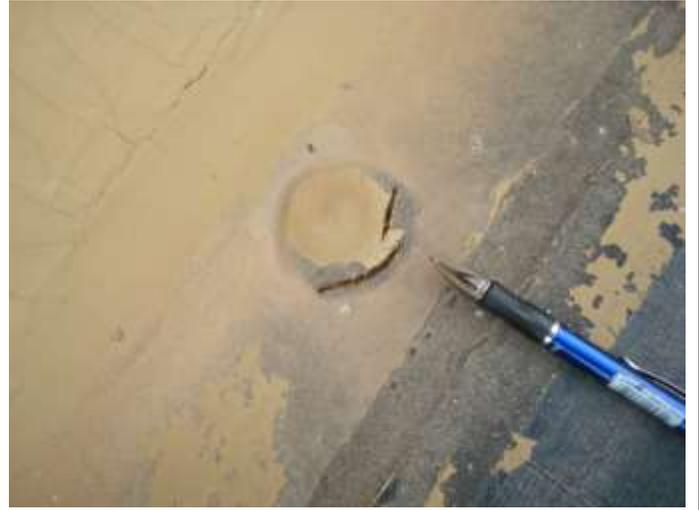
PHOTO 9

A little more pronounced cut/crack. This IS an area where a cut was made into the roof deck to determine if water intrusion has caused problems.

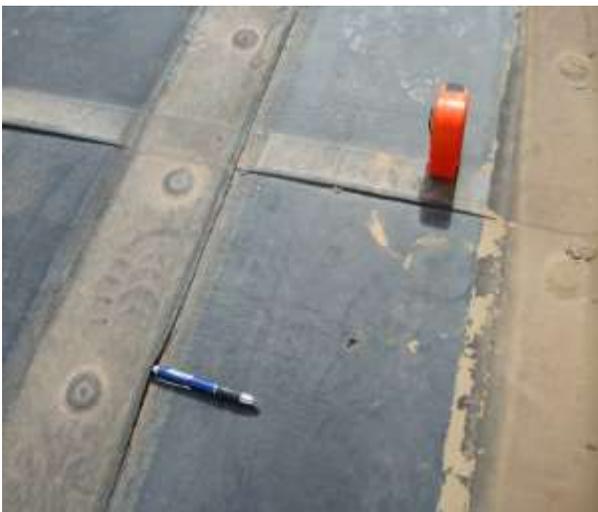
PHOTO 10

Photo shows loose seams between EPDM. To avoid further damage these seams were not probed. They should not be loose.

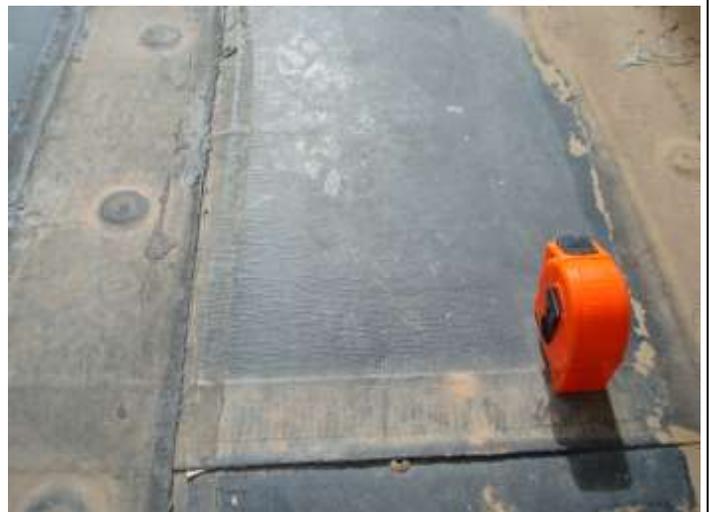
Photo depicts loose seam and checking. Checking is hard to see in the photo but is a sign of aging EPDM subjected to conditions prevalent in Mt Crested Butte. This area will be investigated to the wood deck.

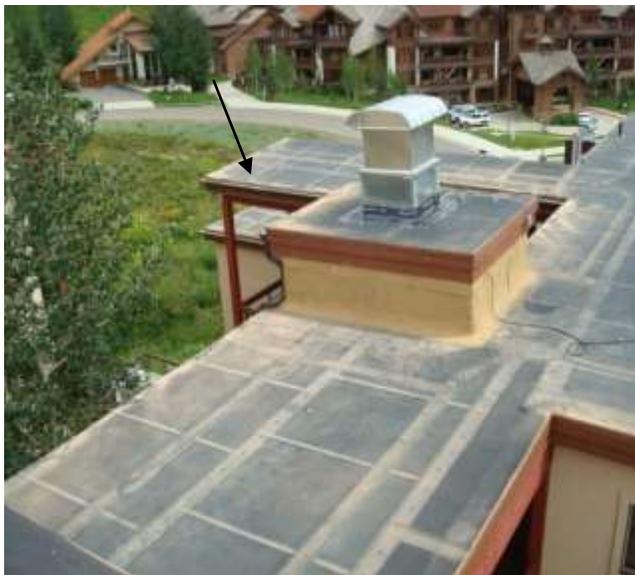
PHOTO 12

Recently installed elevator power ventilation unit. Photo shows temporary “ice and water shield” flashing between sheet metal vent and roof deck. This needs proper flashing.

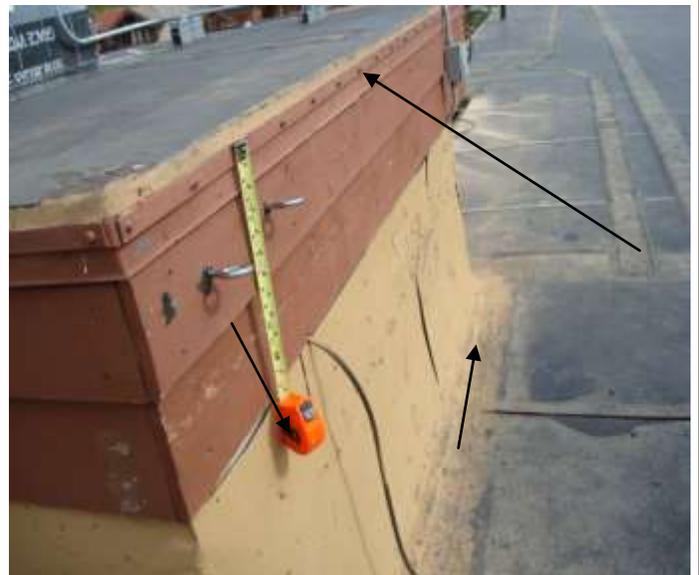
Photo shows loose flashing below wood fascia. Also, metal edging with exposed fasteners. Single ply roofing manufactures today still use the edge metal to hold the single ply along edges but the edge metal is sealed with an adhesive applied membrane strip. Fasteners and metal (termination bars) are not exposed in more modern installations.

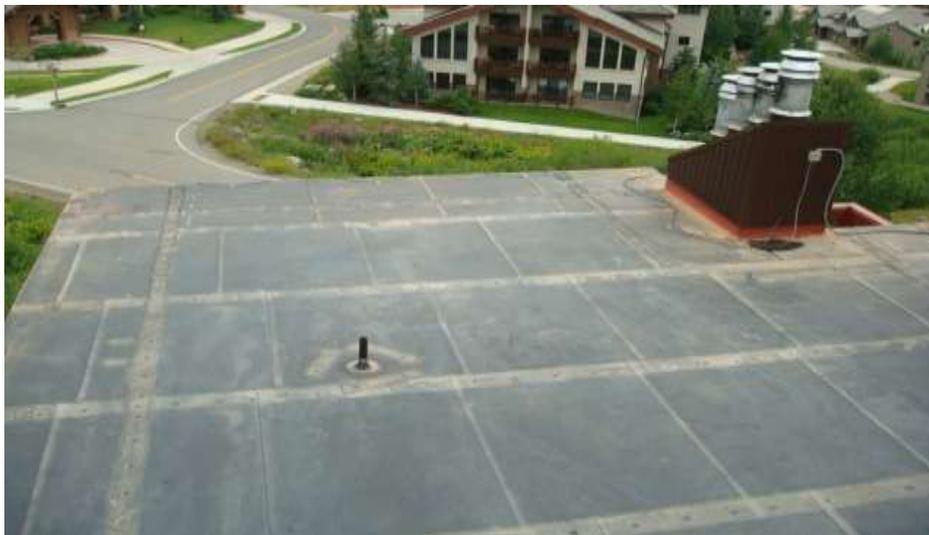
Roof Deck 4 exhibited similar small cracks as other roof decks.

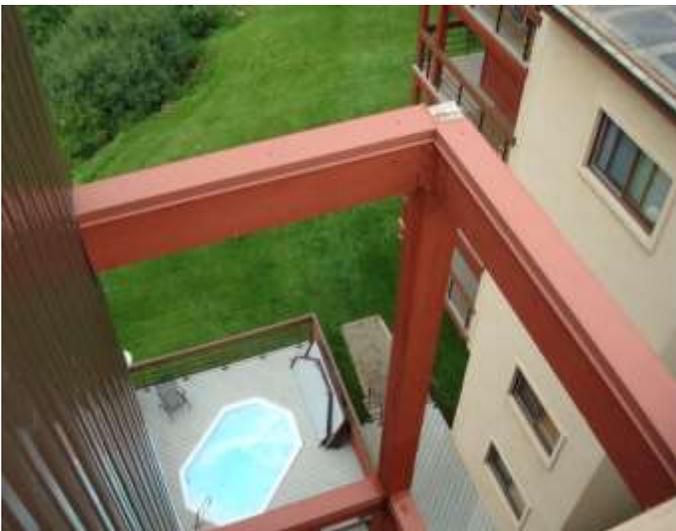
PHOTO 17

Top of wood column exposed to elements.

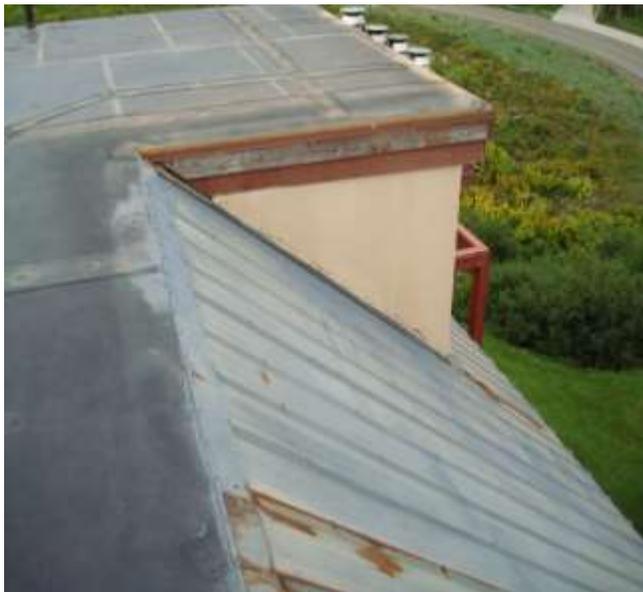
PHOTO 19

Weathered wood fascia and trim. Re-staining should be performed soon. Also, photo depicts aged metal deck.

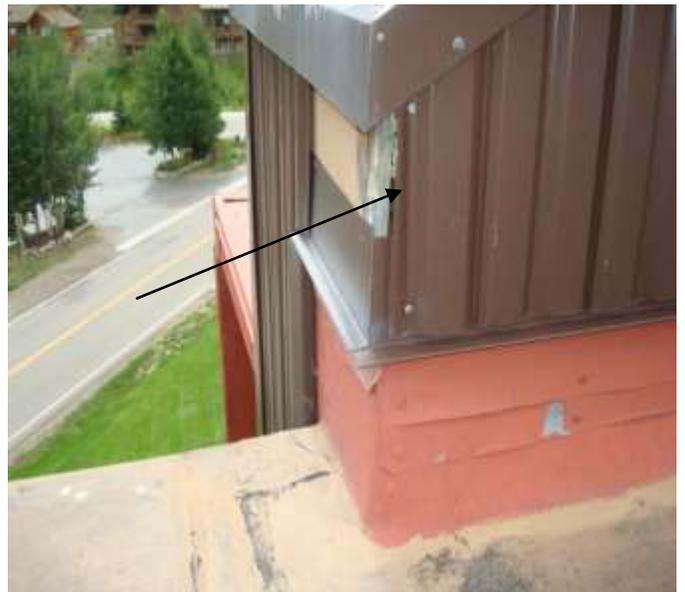
PHOTO 20

Corner flashing damage.

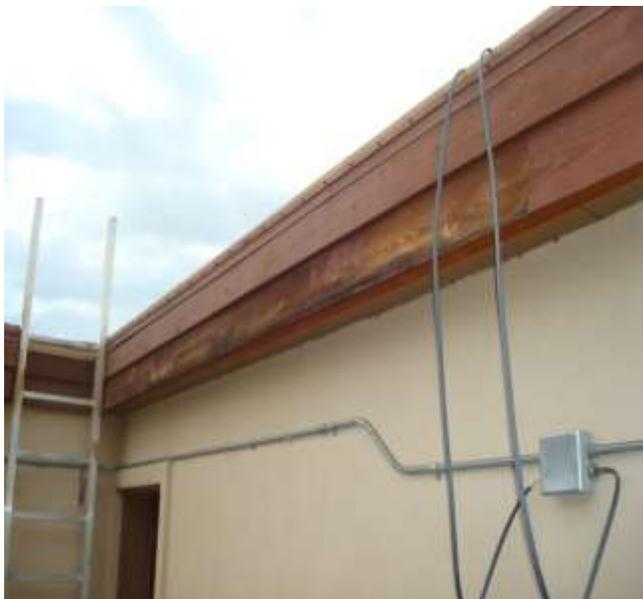
PHOTO 21

Weathered fascia and trim. Re-staining should happen soon.

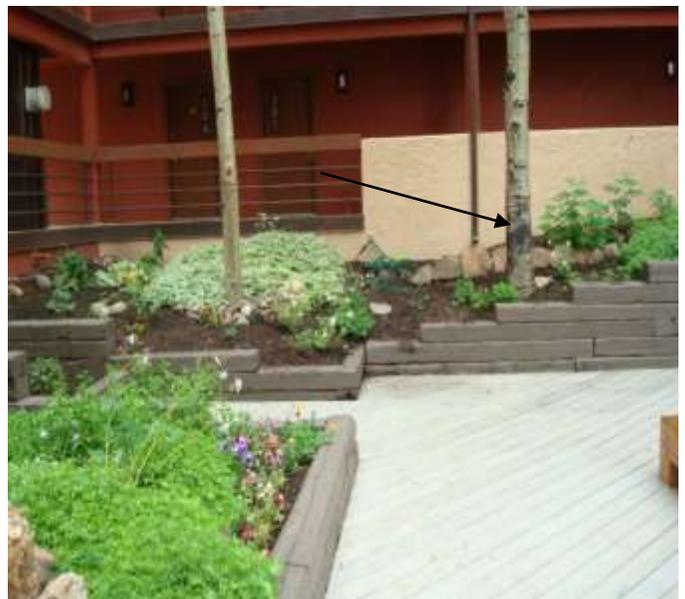
Roof downspout could bring significant water to this area. Is this problematic? Other downspouts could potentially drain water to areas where not wanted. This will be studied further as part of the building and grounds assessment.

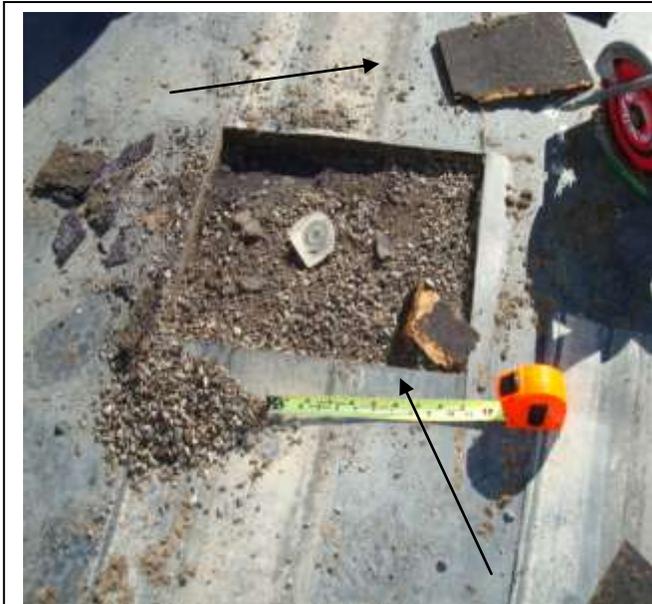
PHOTO 23

Roof deck 3. Directly under the EPDM is a black underlayment that looks like a “celo-tex” material with a 3/8” gravel below. The underlayment material is identified by the arrows.

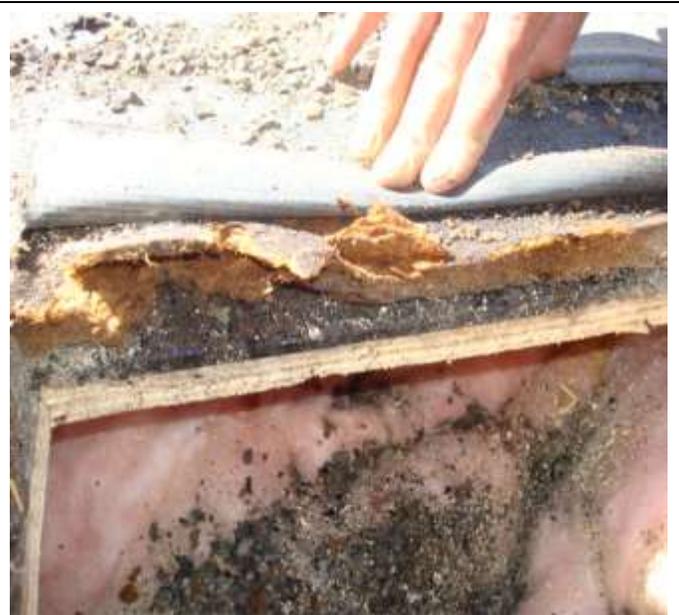
PHOTO 24

Same location as photo 23. Photo depicts EPDM pulled back, underlayment board, gravel, asphaltic material, plywood and insulation. The underlayment is wet. The underside of plywood, insulation and 2x12 joist are dry.

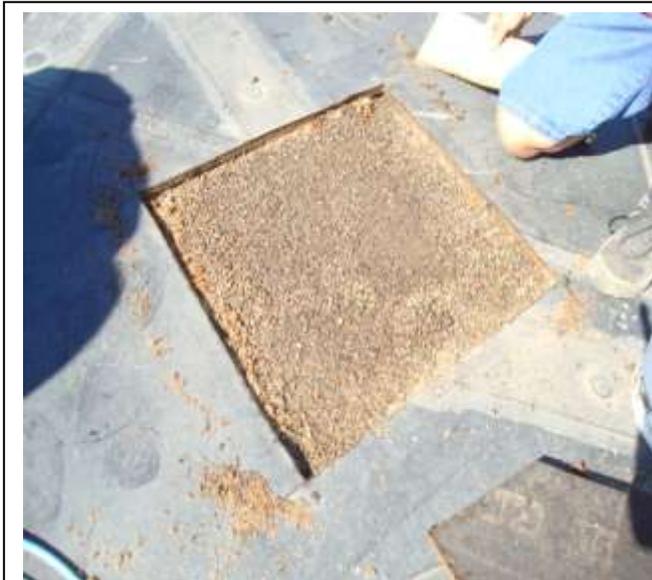
PHOTO 25

Roof deck 1. Underlayment was wet as was the gravel.

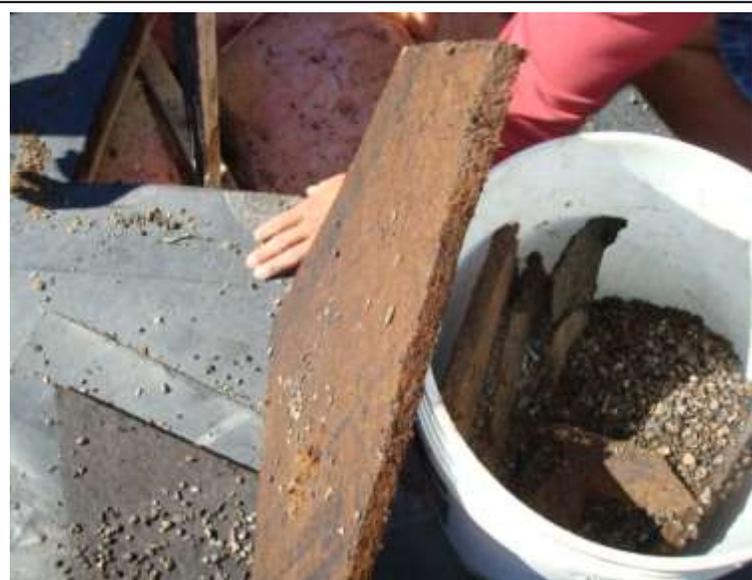
PHOTO 26

Same location as photo 23. Can't really tell in this photo but the underlayment board is completely saturated with water. Underside of Plywood, roof joist and insulation are dry.

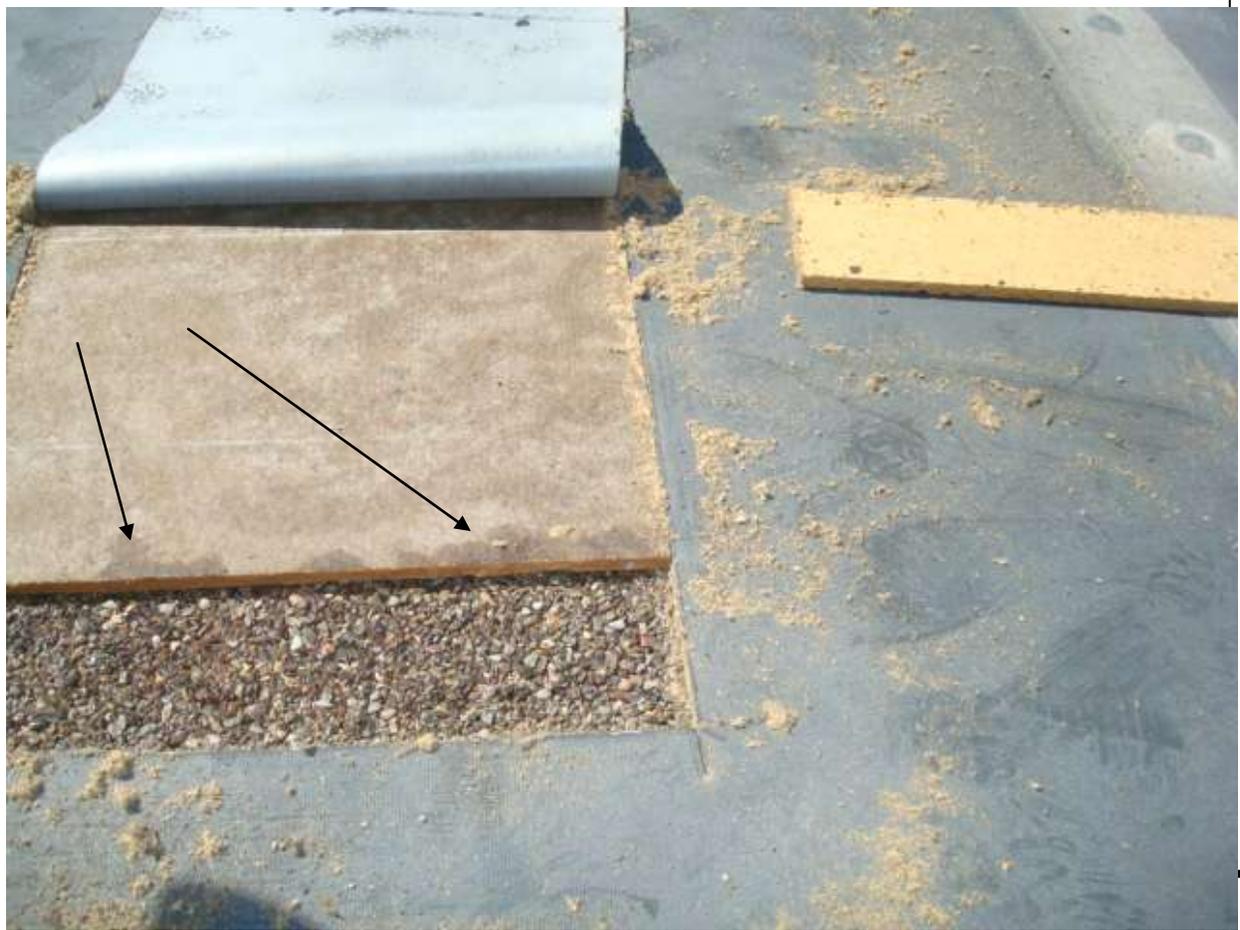
This is roof deck 2, at a location where no cuts or tears were visible. The underlayment and gravel was wet but not as saturated as locations where cuts were present. The dark areas on the underlayment is water brought up by the saw. The gravel in this photo is wet.

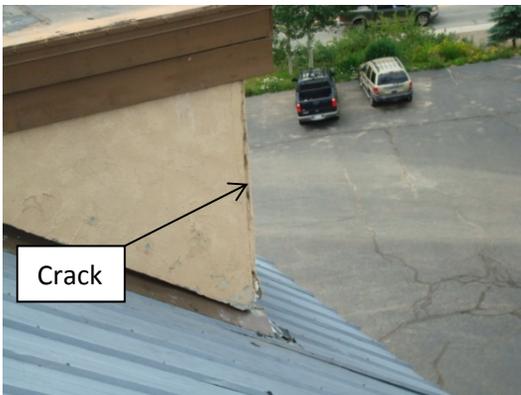
Roof deck number one is the section at the highest elevation on the north side of the building (see attached drawing for further clarification). Two deficiencies were identified in this section of roof. The first concern (photo 1) is large cracks that have developed in the triangular regions of stucco where the roof transitions from flat to sloped. These cracks are a somewhat open conduit to the interior framing of the building. The second concern (photo 2) is the flashing at the base of the fireplace chimneys is loose and not well flashed into the metal siding of the chimneys. This could allow water to infiltrate to the interior structural aspects.

1. Cracks in the stucco siding. The metal roofing can be seen below the stucco

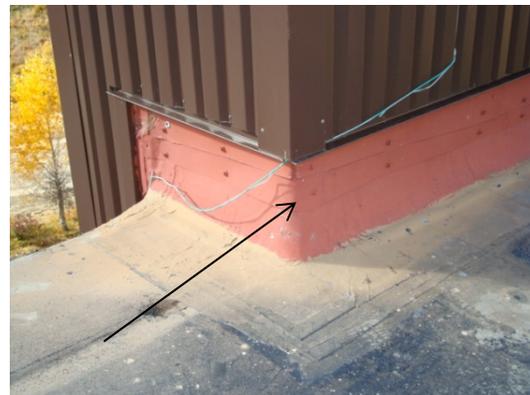
2. Improperly installed and aged flashing. This will be replaced as part of the roofing replacement.

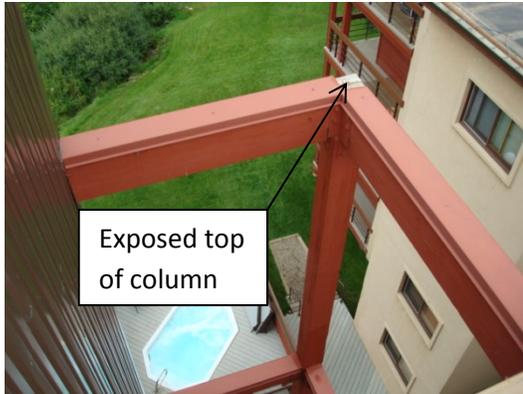
3. The exposed top of column

once again recommended that all wood fascia and soffit be sanded and repainted. At the level of this roof the top of a column is also exposed (photo 3). It is recommended that this exposed wood is properly capped when the fascia and siding is sanded and repainted.

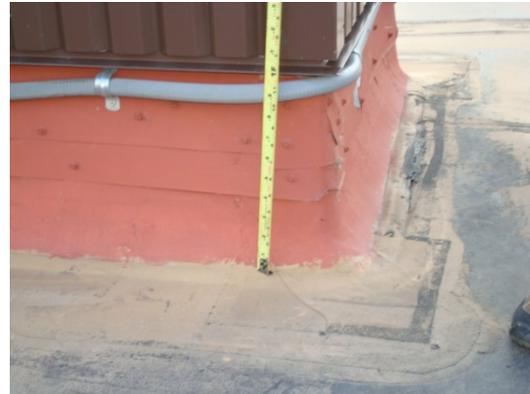
4. An example of an electrical conduit that will need to be removed and replaced

Work in this area is complicated by the presence of an electrical conduit along with gutter, and snowmelt cable. In order to properly sand and paint the fascia and soffit the conduit, gutter, and cables should be removed and then reinstalled (photos 4 & 5). It is also recommended that the snowmelt cables be replaced by a product that can be placed underneath the new EDPM layer. These products are at less risk of being damaged as they are not exposed to the environment. The down side is that they can be harder to repair. Heated Roof Systems Inc. from Aspen Colorado has a radiant heat mat ff

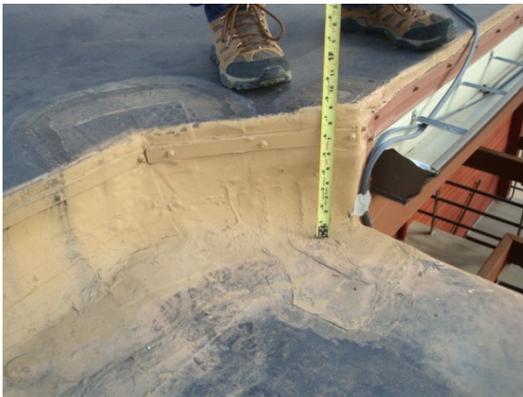
6. The step down between roof decks two and three that should be replaced

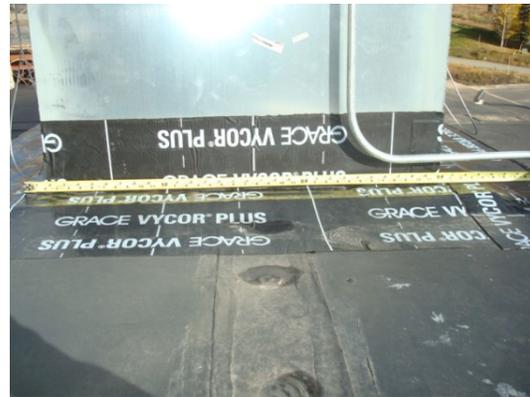
7. A section of the elevator shaft

One unique aspect of this section is the elevator shaft. The flashing on it should be replaced, it should be reroofed, and it should be given an improved slope to enhance drainage. The Grace Ice and Water Shield (photo 7) is only a temporary flashing solution.

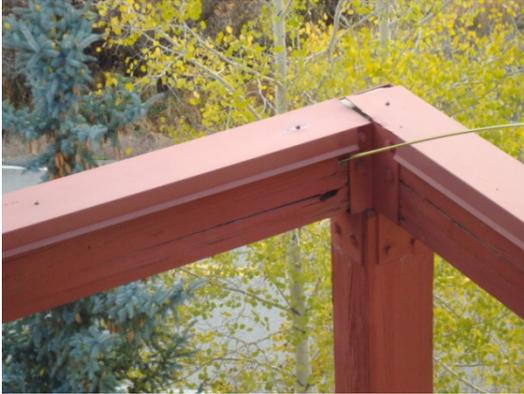
When the fascia and soffit are replaced on this roof deck there is also an exposed beam that should be inspected. It is on the southwest side of the section and appears to have dry rotting and cracking occurring (photo 8 – next page). It was not inspected for safety reasons, but it appears and the beam condition may warrant replacement. During painting we should take a closer look. The access door jamb also needs to be sanded and repainted and then flashing around it needs extra attention when being replaced (photo 9 – next page).

8. Exposed beam that appears to have dry rot and cracking

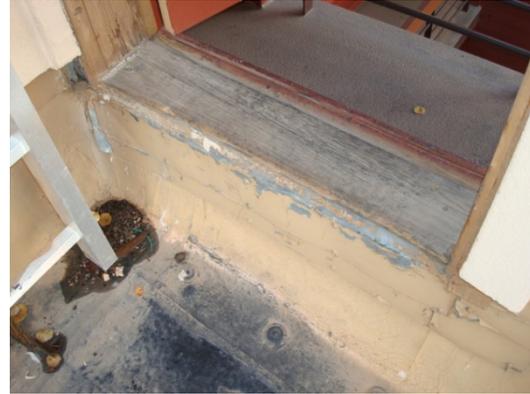
9. Door jamb that should be sanded, repainted, and have flashing replaced

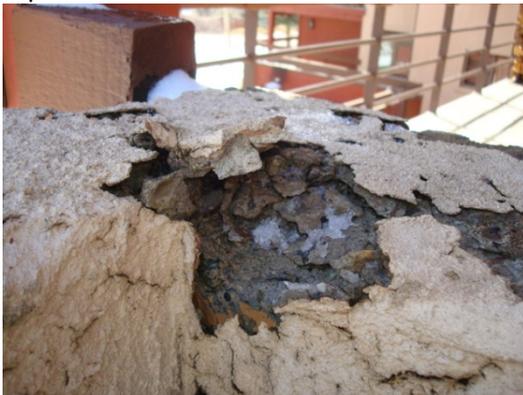
The area that needs additional work is on a stucco covered concrete wall on the east side of the building (photos 10 & 11). The stucco was installed on both a vertical and horizontal surface over a concrete wall in this area. The horizontal surface (top) allowed water to penetrate and work between the wall and vertical stucco. This in turn leads to freeze thaw conditions because there is no way for the water to drain. The concrete substrate under the stucco is beginning to break apart and fail due to the freeze thaw action. It is SGM's recommendation that the stucco should be completely removed from this wall. The wall surface should be refinished with an epoxy grout material, and sealed to prevent further freeze thaw damage. The concrete wall could be left as exposed "finished" concrete or the stucco reapplied with better detailing at the top.

10. Water within the concrete. This results in freeze thaw damage.

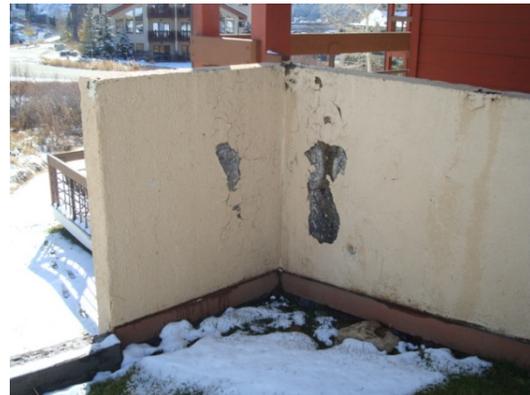
11. Damage down the side of the wall due to water infiltration

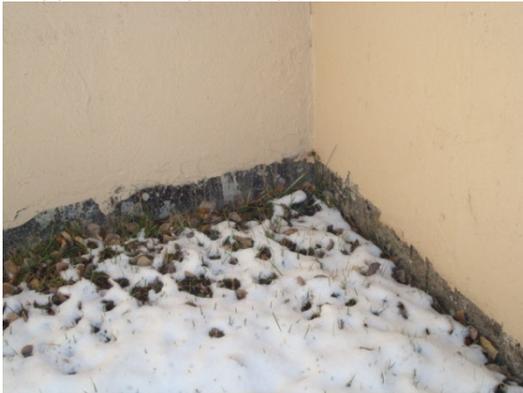
12. Stucco siding exposed to the ground surface

Other stucco areas that need to be addressed are readily visible and described below. Some areas of note that need this work done are above the retaining wall just to the north of the porte-cochere, portions of the north and east sides of the building, and one small section on the south side of the building. Near the porte-cochere there is no barrier between the earth and the stucco siding. When this section of stucco siding is replaced a barrier or type of flashing should also be installed to avoid the infiltration of water. The total area in need of stucco repairs is approximately 600 square feet.

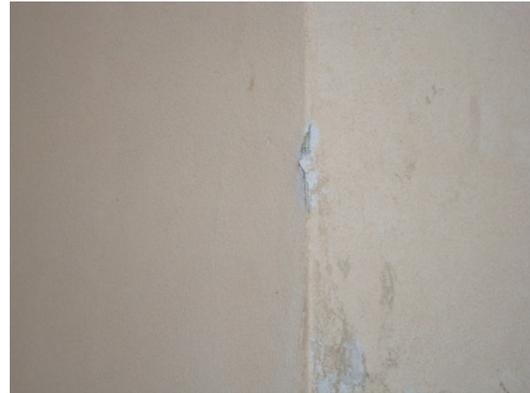
13. Large crack on the north side of the building

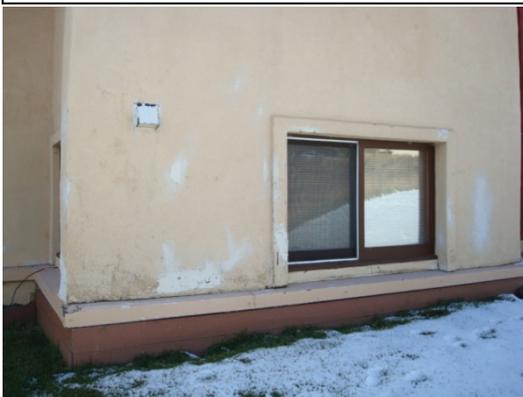
14. Area on east side of building in need of stucco rehabilitation

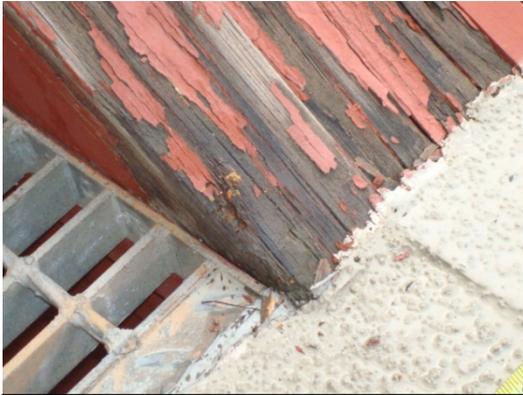
16. Dry rotting stringer due to pooling of water

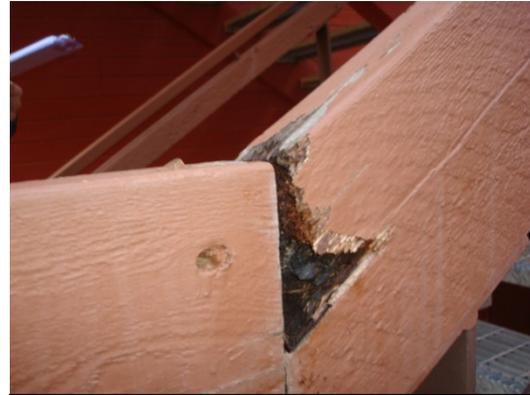
17. Rotted out handrail

The replacement of the handrail and repainting of all members are not integral to the structural integrity of the building but could be safety concerns. Handrail replacement is a building code and an aesthetic issue while the repainting of all members will extend their service lives. It is our understanding that the board is well aware of the handrail code requirements.

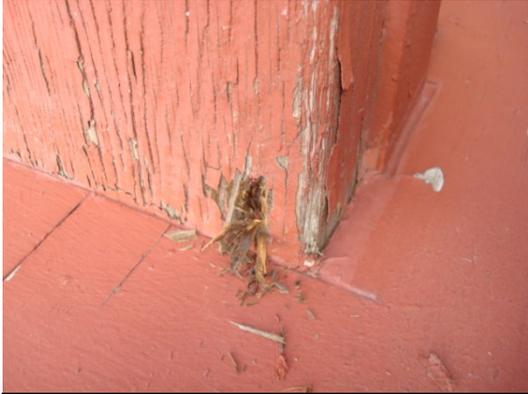
The on-site inspection found six columns that pose a potential problem to the structure. The first of these columns bears in the concrete of the second floor next to the bike rack that is to the north east of the porte-cochere. The bottom of this column is in the beginning stages of dry rotting, but has not advanced to the point that it should be replaced. It is recommended that the lower portion of this column be scraped well, sanded, and then repainted to prevent further dry rot. As with the stringers in the stairwells, an oil based primer and latex paint should be used to keep as much moisture from penetrating the wood surface as possible.

18. Dry rot at the base of the column north of the porte-cochere

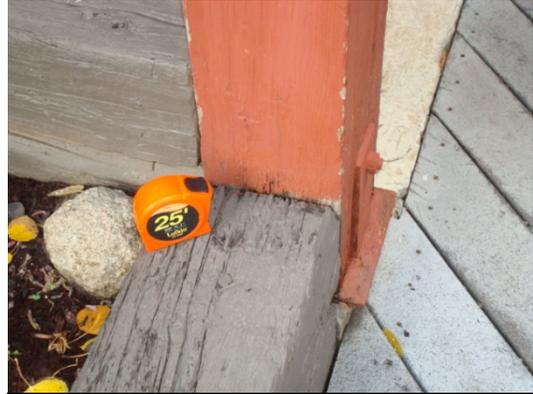
19. Intersection between stairwell column and garden timber retaining wall

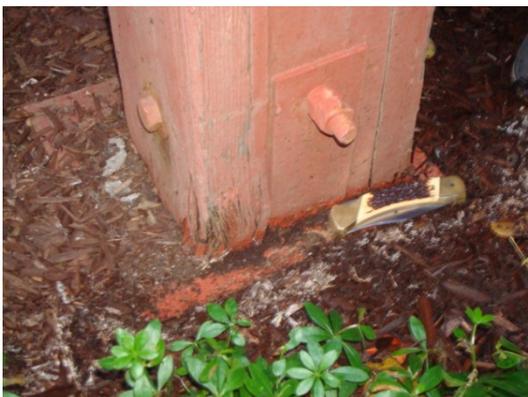
Each of the other four columns are in a condition that warrant replacement. The first is located on the south stairwell directly to the west of the column that was just discussed and it bears on a concrete footing in the garden. This column has evidence of both dry rot and crushing. It appears to have begun to split previously and bolts were installed near the base to prevent further splitting. It is recommended that this column is removed from the elevation of the second floor down and replaced. This will require a splice to be installed where the old columns meets the new replacement column.

20. Crushing, dry rot, and splitting in a column in the south stairwell

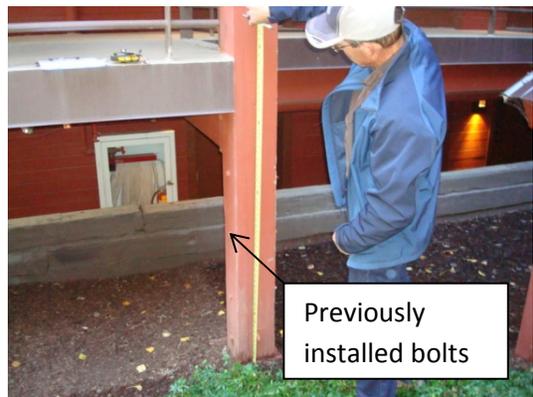
21. Previously installed bolts in a column in the south stairwell

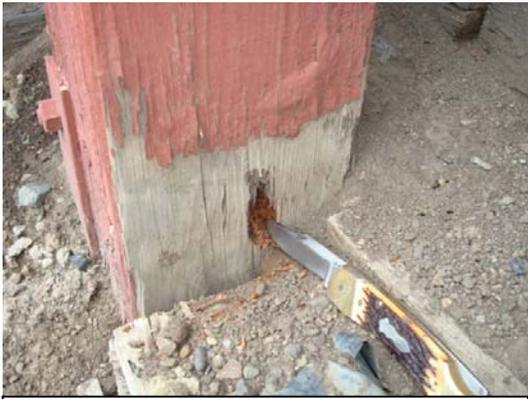
22. Dry rot in a column

For this task temporary shoring will be required to be installed to allow the removal and replacement of the members. There are a number of quality and trusted contractors in the Crested Butte and Gunnison area that are qualified to do this work. We would recommend soliciting for bids from selected contractors. The selected contractor should have the proper insurance limits, project bonding capability and a track record of similar project experience.

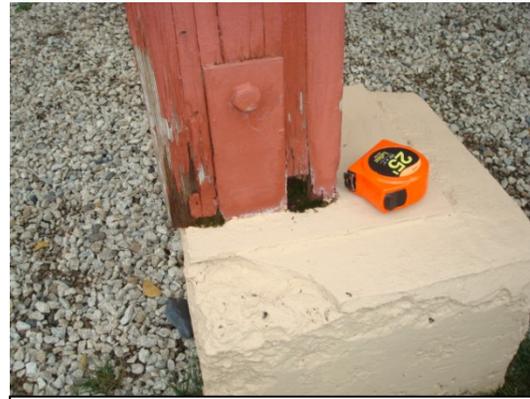
23. Dry rot in a column

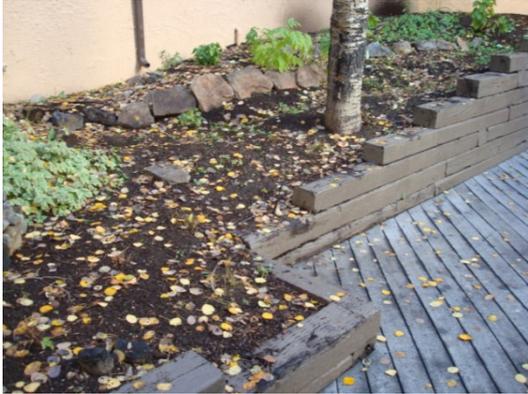
The synthetic decking in the courtyard area that extends to the hot tub area is in fair condition. The decking does show signs of moisture absorption and some areas appeared “spongy” under foot. The photos below (photos 24 and 25), if viewed in a color photo, show darker areas indicative of moisture saturation. Most likely the moisture problem is a combination of the roof drainage into this area and overall lack of drainage below the decking. At this time we can’t say that this is a structural issue, more of an aesthetic issue. The moisture problem will reduce the life of the decking and the condition of the sub structure is unknown. At some point within the next 5 years or so this should be addressed. It is also recommended that when the decking is replaced the roof and area be drained to daylight (Wood Creek perhaps).

24. Roof down spout and lack of area drain places water below deck and within timber retaining wall.

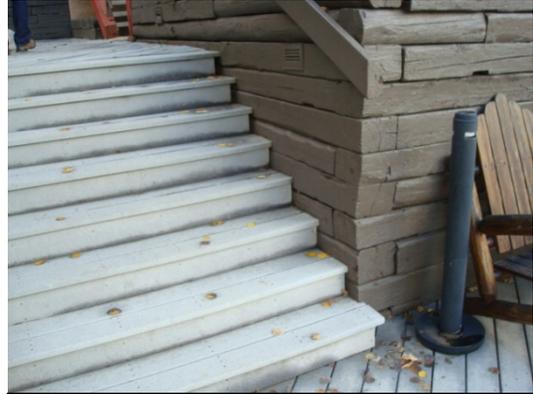
25. Moisture within the decking stairway evident by dark areas. It should be noted that the paint on the timbers will hold moisture and prevent the timbers from drying.

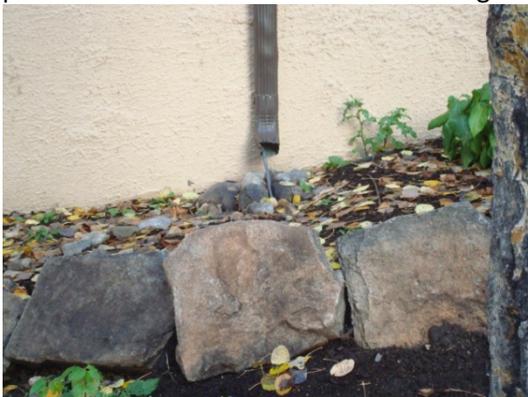
During this on-site inspection there were several areas with drainage deficiencies. There were three areas at which the drainage was poor due to drain pipe outlets from the roof. The first of these is in the large garden in the courtyard. This is not an ideal place to have a drain outlet because of the large amounts of water draining from the roof produces a larger amount of water than can be saturated into the garden soils. This results in the water draining under the deck which poses a potential problem to its structural integrity. The other two potential problems are to the west and east of the hot tub deck. These drain pipes empty into the yard directly next to the building. Once again because of their close proximity to decking each has the potential to flow underneath the decking and causes problems with the structure.

26. Drain pipe into garden above decking

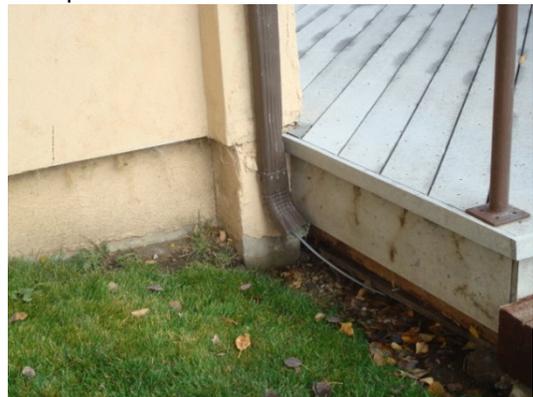
27. Drain pipe into yard next to porch

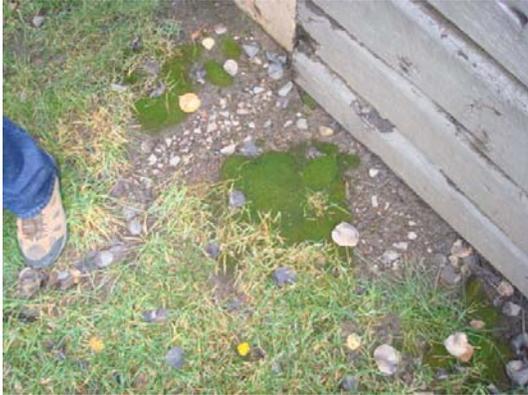
The other drainage issue is to the right of the main entrance on the west side of the building behind the retaining wall. The crest of the hill behind the retaining wall is located in an area that creates a low spot at the intersection of the retaining wall and the structure. This has resulted in deterioration of the retaining wall and an excess amount of water around the foundation.

28. Moss growth where water is draining down the backside of the retaining wall.

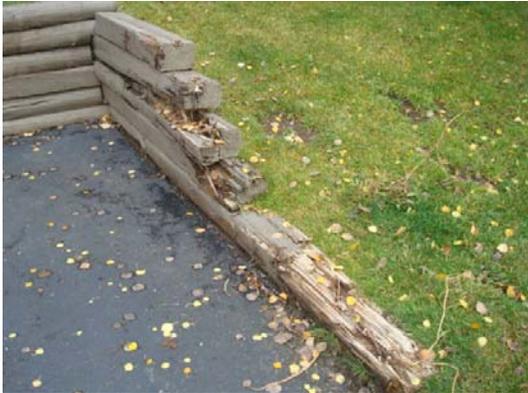
All of the timber retaining walls around the structure are nearing the end of their service lifespans and will eventually need to be replaced. This is an aesthetic issue more than a structural issue as none of the retaining walls are an integral part of the structure of the building or are tall enough to pose a safety threat. Despite this they will all have to be replaced in the near future because of the dry rot that has eaten away at the timbers these walls are built of. Another problem these walls are facing is that the paint on them has exacerbated the dry rot problem by sealing moisture within the timbers.

29. Dry rot in retaining wall to south of main entrance

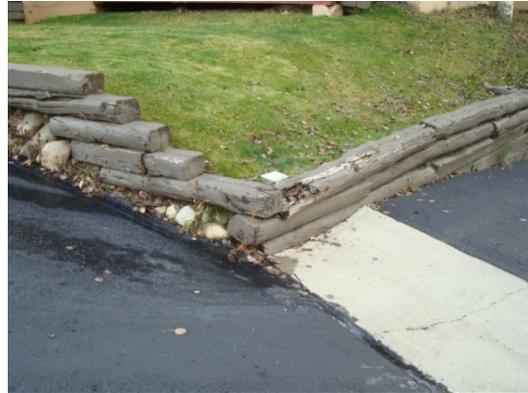
30. Dry rot in retaining wall north of main entrance

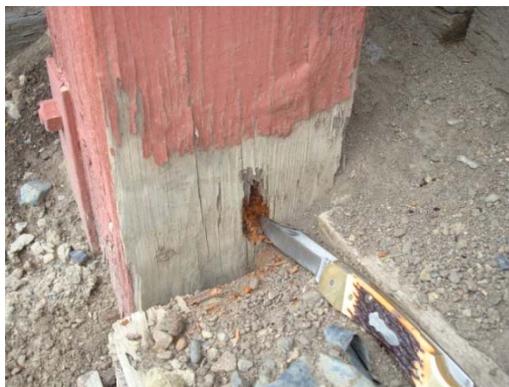
Figure 2: Rot on Column Exterior and Dirt Piled on Top of Column

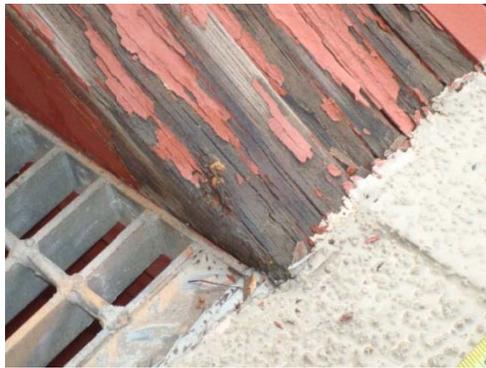
Figure 4: Rot and Moisture at Base of Stringer

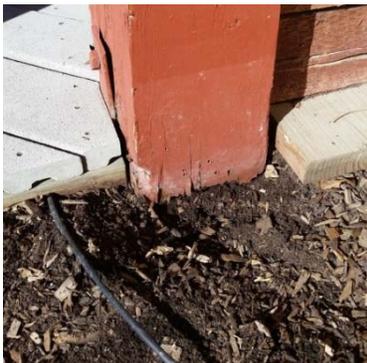
Figure 7: Rot at Column Base

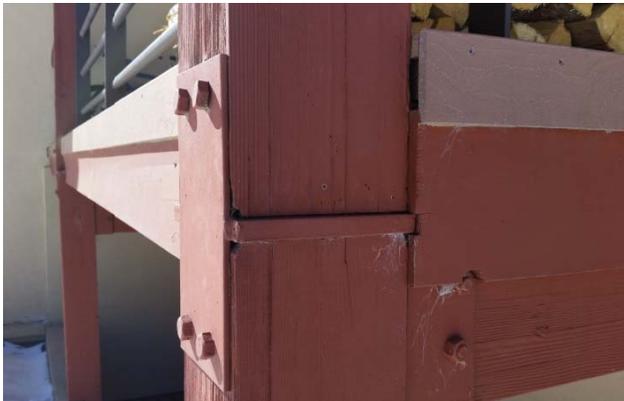
Figure 9: Existing Splice in Column at Balcony Level

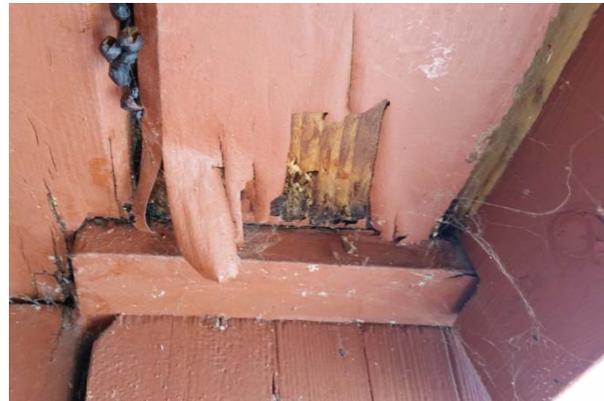
Figure 10: Rot on Underside of Balcony
