TO: Wood Creek Lodge Homeowner's Association

RE: Roofing Replacement Project Update, Week of 6/22-6/26

DATE: June 29, 2015

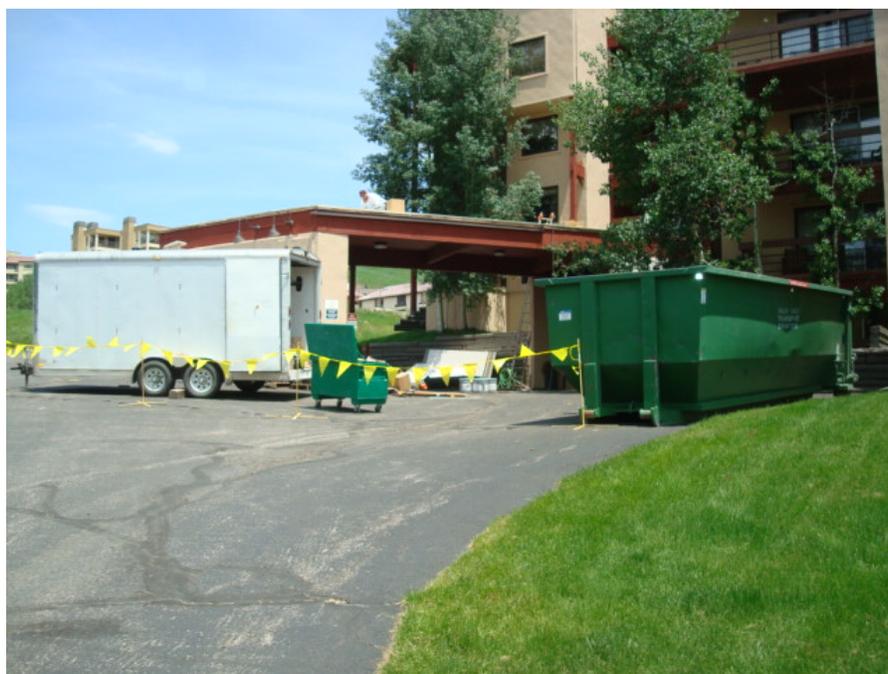
Photo 1: This photo shows where they have set up their construction dumpster. Their supply trailer is also shown here, but it has now been moved to the north side of the building where the permanent dumpster sits and their crane is where the trailer is in this picture.

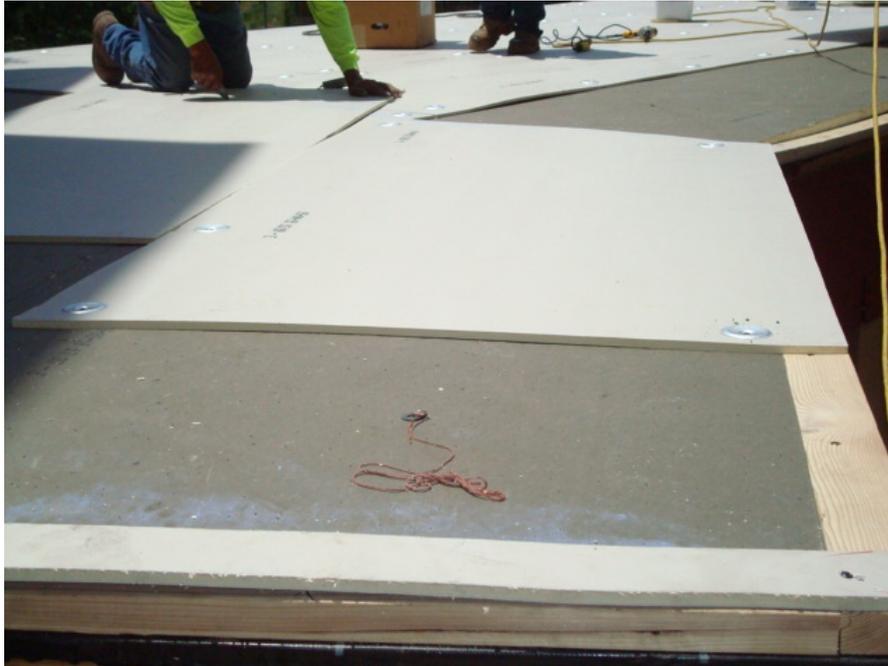
Photo 2: Here the installation of the sub-roof materials over the porte-cochere is shown. This roof was completely replaced after their first day of work. In this picture as well as several below, the circular silver disks that are being used to mechanically fasten the insulation and cover board can be seen. The hold down the roof and then the EPDM layer is glue on top of that.

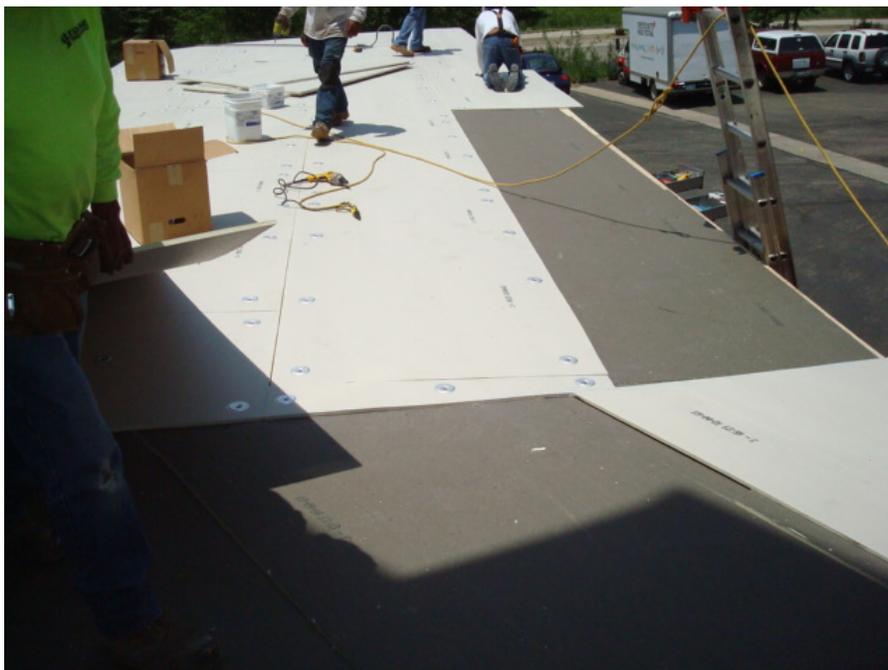
Photo 3: Another shot of the sub-roof materials over the porte-cochere

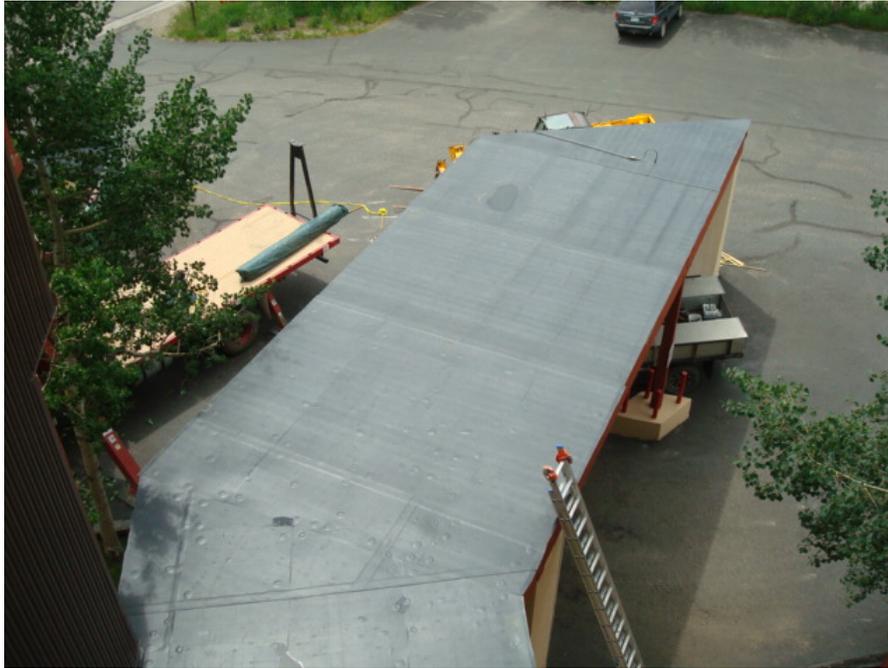
Photo 4: Bird's eye view of the finished product on the porte-cochere. Small air bubbles can be seen on the left side of the roof, but these occur regularly when installing a roof like this and disappear after several days.

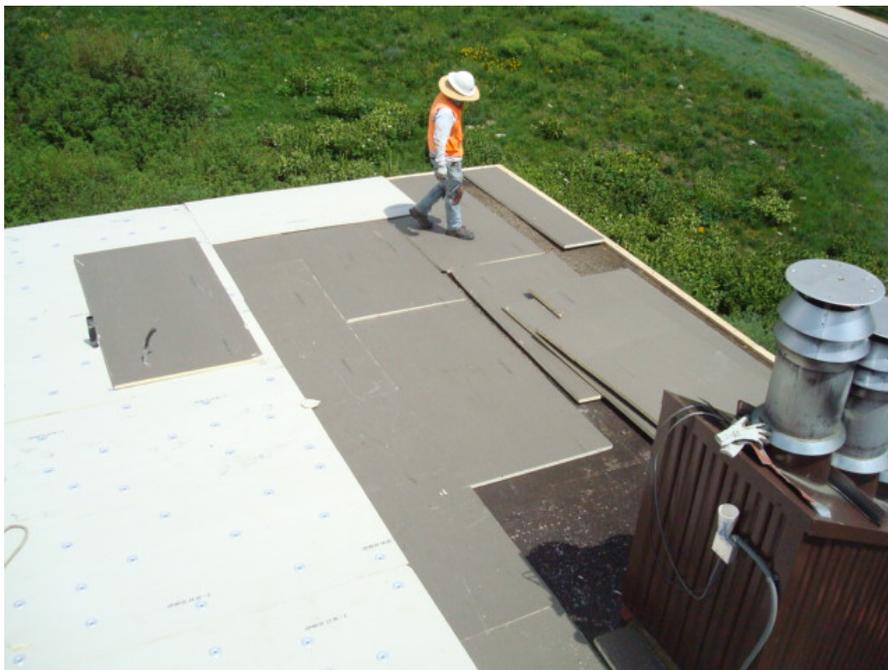
Photo 5: This is the installation of sub-roof materials on the south side of the building. Here you can see the bottom gray layer of insulation as well as the top white layer of insulation.

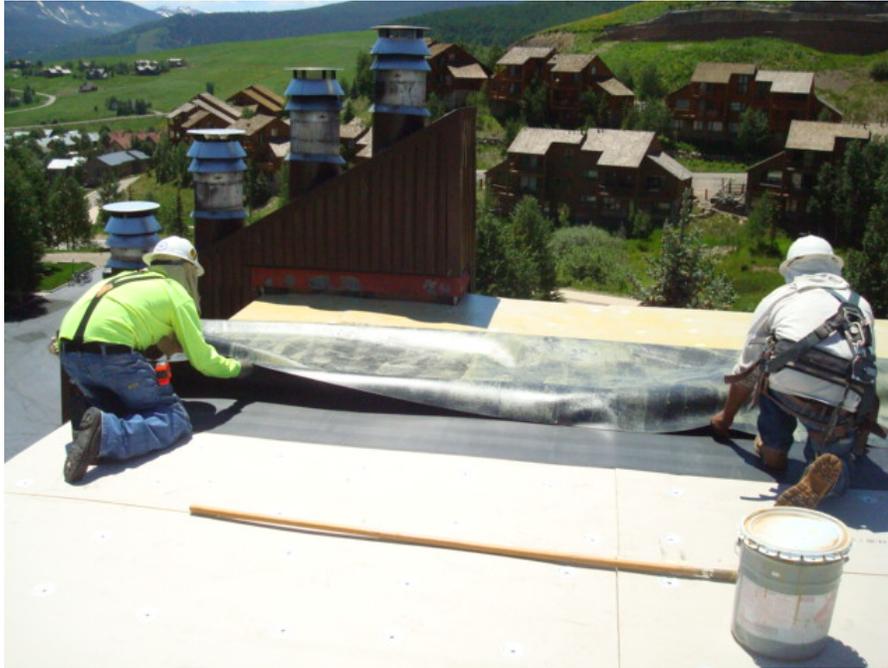
Photo 6: The Carlisle roofing membrane is glued on top of the insulation layers on the southwest corner of the building. Glue is placed on the insulation layer as well as the EPDM roof membrane layer.

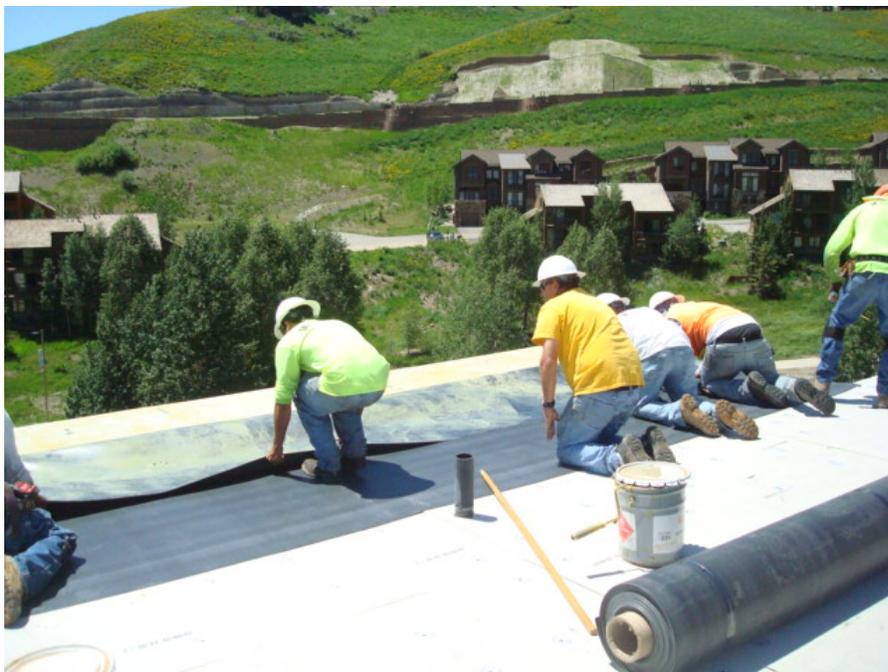
Photo 7: Another shot of the EPDM layer getting glued on the southwest corner of the building.

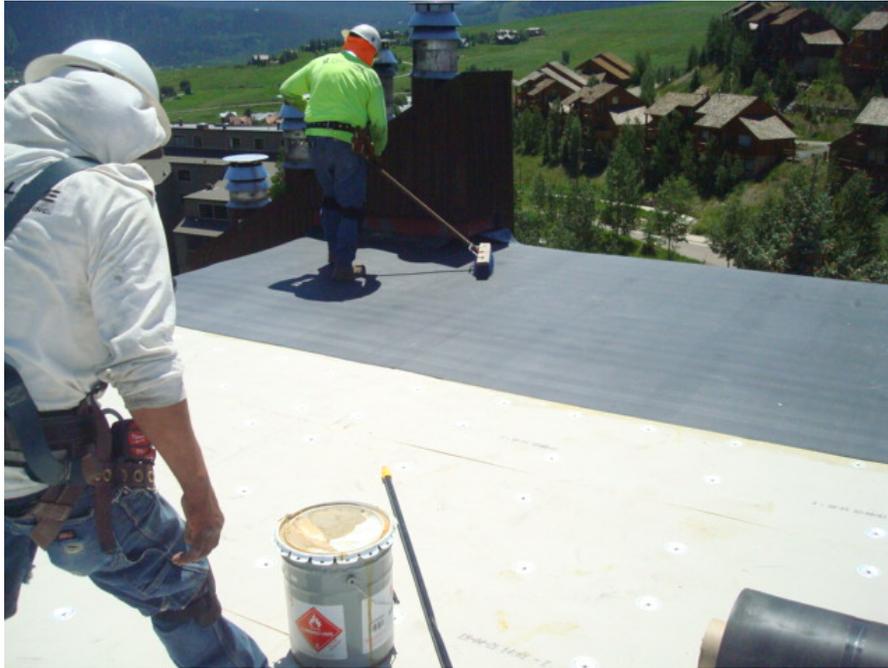
Photo 8: The EPDM layer that was shown getting glued on in the above pictures when finished.
