# **WOOD CREEK LODGE**

CRESTED BUTTE COLORADO

## **CAPITAL IMPROVEMENT PLAN STRATEGY**

**MAY 6, 2015**

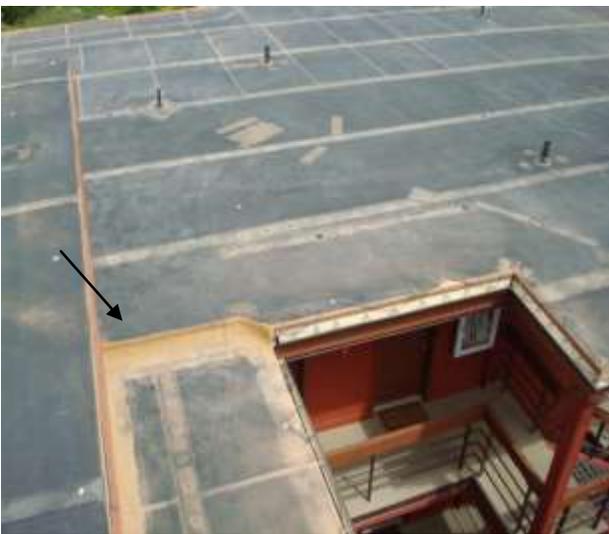
PHOTO 5

This photo shows Roof Deck 2 from Roof Deck 1. There is a 10" step down from Roof Deck 2 to Roof Deck 3.

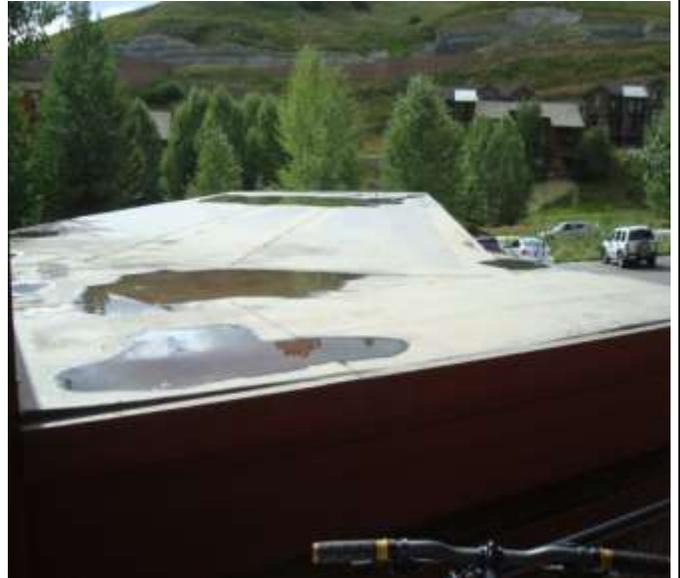
PHOTO 16

The entry porte-cochere roof deck exhibits minor ponding and similar small cracks as noted elsewhere. The ponding is not ideal but not overly concerning for this type of roofing material not over living space. This indicates that the other roof decks drain well. Often times flat roof decks will not drain and ponding can be problematic or allow water to sit over small cracks and seep into the deck underlayment.

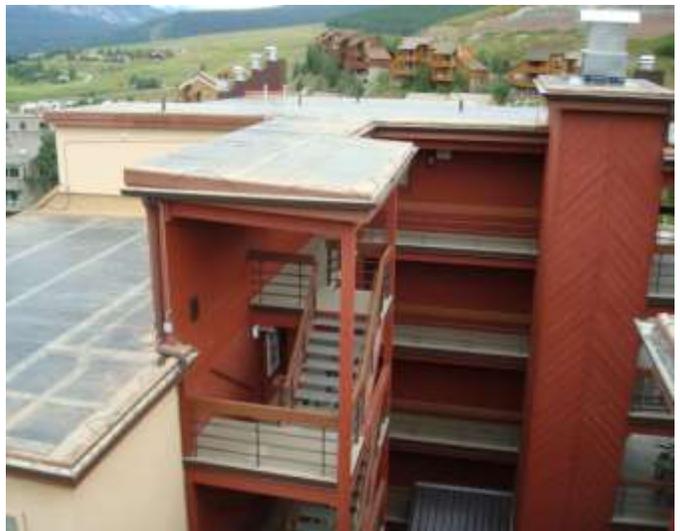
PHOTO 18

Photo depicts slope on roofing for drainage along with gutters, down-spouts and snowmelt cables. Good details that we will want to maintain.

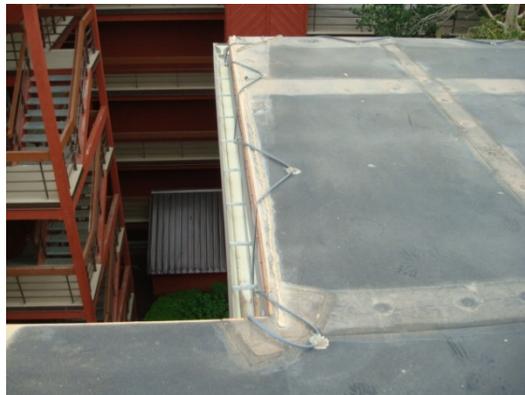
Work in this area is complicated by the presence of an electrical conduit along with gutter, and snowmelt cable. In order to properly sand and paint the fascia and soffit the conduit, gutter, and cables should be removed and then reinstalled (photos 4 & 5). It is also recommended that the snowmelt cables be replaced by a product that can be placed underneath the new EDPM layer. These products are at less risk of being damaged as they are not exposed to the environment. The down side is that they can be harder to repair. Heated Roof Systems Inc. from Aspen Colorado has a radiant heat mat ff

5. An example of the snowmelt cables that could be replaced.

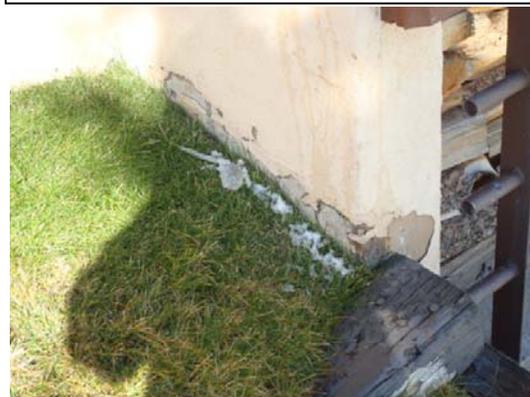
15. Small section on the south side of the building in need of rehab
